AMBERFIELD HOA - CSG Project # 17-096

Updated 9/26/2017

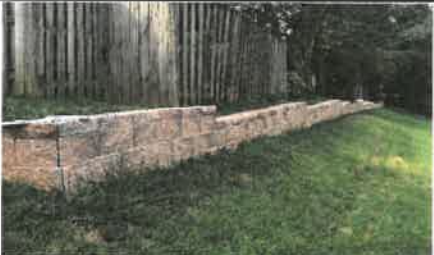
Item #	Description	Length (Feet)	Height (Inches)	Face Area (SQFT)	Permit Required (>48")	Fence Required (>40")	Preliminary Replacement Cost Estimate (excludes fence/guards)	Redi-Rock Preliminary Replacement Cost Estimate (excludes fence/guards)	Grade	Phase of Work	Notes	Photographs
1	Retaining Wall	150	26	325	No	No	n/a	n/a	Good	n/a	Modular block retaining wall with 11 different steps; includes cap stones; no rotating sections; Possible underground utility issues.

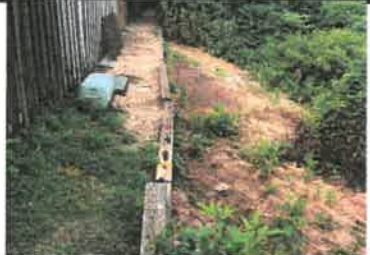
2.A	Retaining Wall	160	35	467	Yes	Yes	\$35,000	n/a	Poor	1	Lower wood retaining wall, varies in height from 11" to 60", will need fence on section, deteriorated dead man and starting to rotate, soil erosion on downhill side of retaining wall, possible underground utility lines.

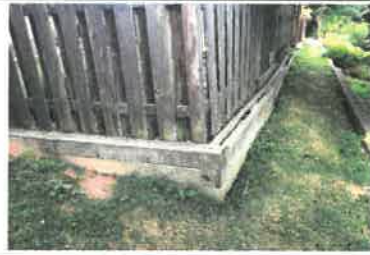
2.B	Retaining Wall	n/a	n/a	n/a	n/a	n/a	n/a	n/a	Poor	n/a	NOT COMMON ELEMENT PER Email on September 25, 2017.

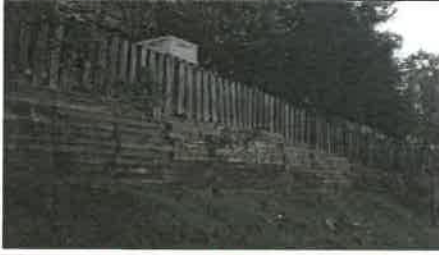
3	Retaining Wall	180	72	1,080	Yes	Yes	\$70,000	\$80,000	Poor	1	Wood retaining wall with shadow box fence, typically 72" tall but falls off to 0" at ends, several trees may need to be removed; wood timbers and deadman are deteriorated especially at the base of wall.

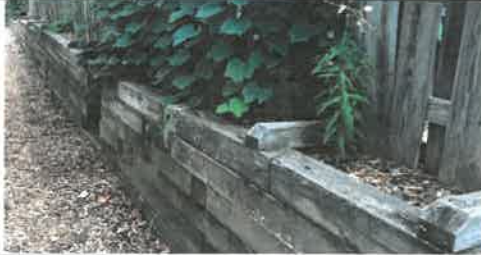
4	Retaining Wall	70	30	175	No	Yes	\$15,000	\$25,000	Poor	1	Wood retaining wall at rear of residences, includes fences and individual stairs; the adjacent "block" planters have been excluded, varies in height from 21" to 33".

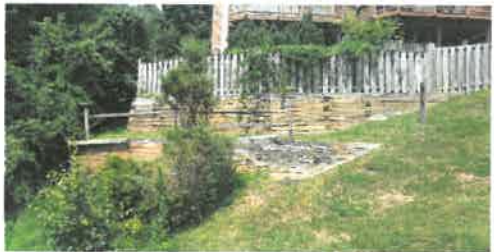
5.A	Retaining Wall	65	55	298	Yes	Yes	\$23,000	\$55,000	Poor	1	Upper tier of wood retaining wall, deteriorated wood especially located at interlocking corners.

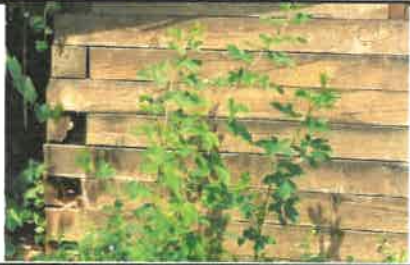
5.B	Retaining Wall	57	62	295	Yes	Yes	\$22,000		Poor	1	Lower Tier of wood retaining wall, has dislodged membrane and a split rail fence in poor condition.

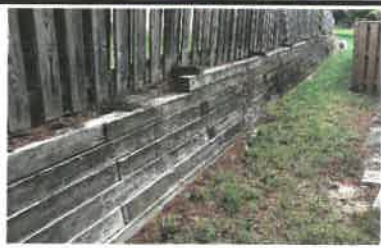
7	Retaining Wall	80	40	267	Possible	Yes	\$20,000	n/a	Fair-Poor	2	Wood retaining wall with shadow box fence, top course is deteriorated, sidewalk sections will have to be removed, possible electrical lines in vicinity. Fence is in poor condition.

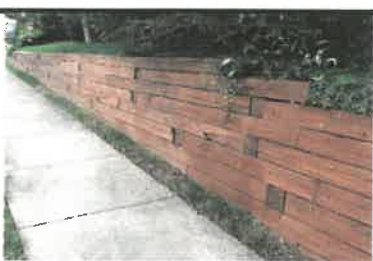
8	Retaining Wall	62	45	233	Possible	Yes	\$16,000	n/a	Poor	1	Wood retaining wall; approximately last 20 feet to be reset and additional Deadman added.

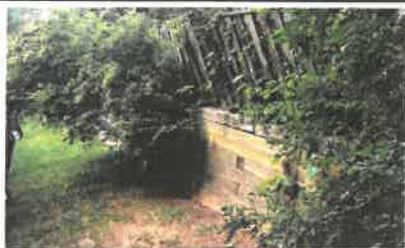
9	Retaining Wall	95	70	554	Yes	Yes	\$37,000	n/a	Fair-Poor	2	Adjacent to building foundation, vegetation overgrowth needs to be trimmed back as it is undermining the stability of the fencing; deterioration to at least one deadman.

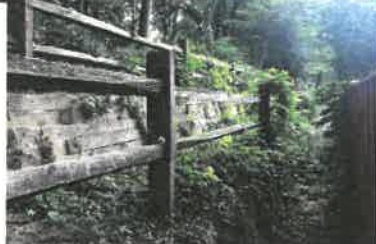
10.B	Retaining Wall	330	50	1,375	Yes	Yes	\$100,000		Fair-Poor	2	Lower wood retaining wall with minimal observed deterioration; residential fences and vegetation are concealing condition. Sections have split rail fence on top without wire mesh.

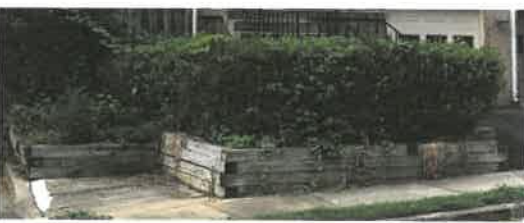
11.A	Retaining Wall	n/a	n/a	n/a	n/a	n/a	n/a	n/a	Poor	n/a	NOT COMMON ELEMENT PER BOARD MEETING ON September 5, 2017.

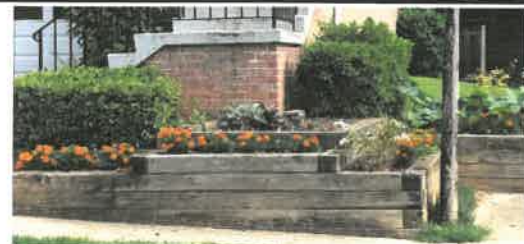
11.B	Retaining Wall	n/a	n/a	n/a	n/a	n/a	n/a	n/a	Fair	n/a	NOT COMMON ELEMENT PER BOARD MEETING ON September 5, 2017.

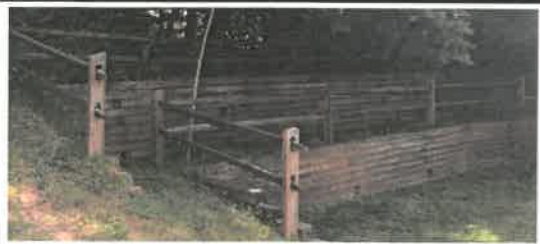
12.A	Retaining Wall	92	55	422	Yes	Yes	\$30,000	\$65,000	Fair	2	Upper Wood Retaining Wall; no significant deterioration observed. Has a split rail fence with welded wire mesh which is unsound, however, due to the lack of foot traffic access, not necessarily a fall hazard.

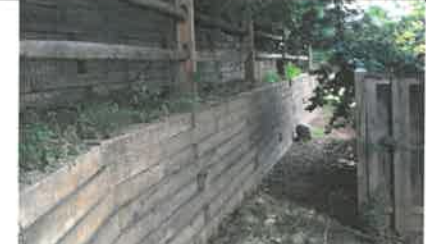
12.B	Retaining Wall	97	45	364	Yes	Yes	\$27,000		Fair-Poor	2	Lower Wood Retaining Wall, no significant deterioration observed. Has a split rail fence with welded wire mesh. Residents should be instructed not to pile yard debris against retaining wall.

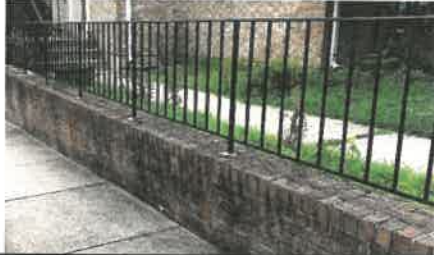
13	Retaining Wall	52	46	199	Possible	Yes	\$16,000	n/a	Fair	2	Brick Retaining Wall with a 35" tall metal fence. There are currently 4 vertical cracks running the height of the wall, this should be repointed and periodically checked for growth in cracks.

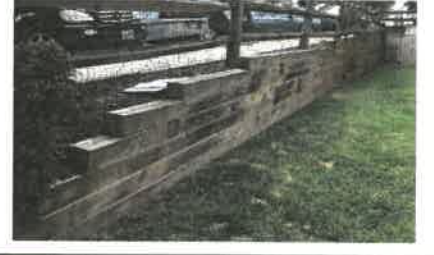
14	Retaining Wall	235	69	1,351	Yes	Yes	\$95,000	n/a	Poor	1	Wood Retaining Wall with split rail/wire mesh fence. The retaining wall is rotating near parking spaces and bulging at the rear of the units.

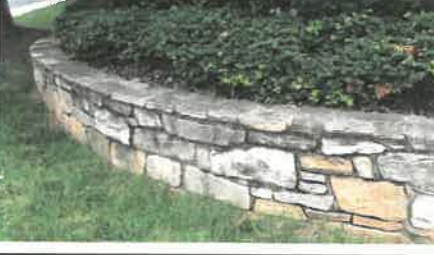
15	Retaining Wall	50	24	100	No	No	n/a	n/a	Good	n/a	Stone Retaining Wall, excludes adjacent wood retaining wall at front of unit which appears to be residential responsibility.

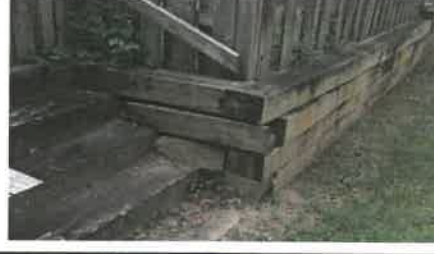
16	Retaining Wall	70	38	222	Possible	Yes	\$15,000	n/a	Poor	1	Wood Retaining Wall which is deteriorated especially at the first course and the resident unit stairs, numerous trees to be removed, residential fencing and stairs will be disturbed.

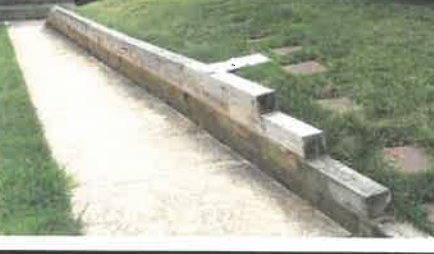
17	Retaining Wall	55	23	105	No	No	\$9,000	n/a	Poor	1	Wood Retaining Wall on the side of the building is rotating towards the sidewalk.

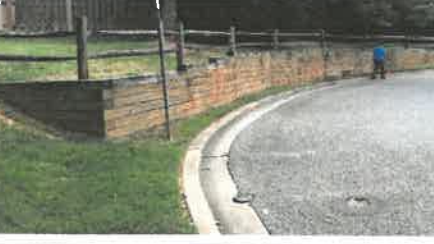
18	Retaining Wall	75	56	350	Yes	Yes	\$25,000	n/a	Fair	2	Wood Retaining Wall with split rail fence; no significant deterioration observed.

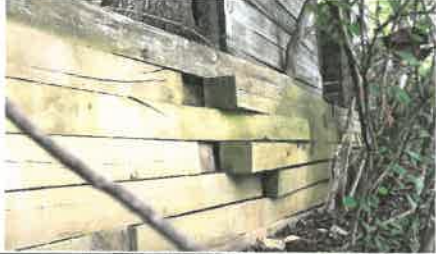
20.A	Retaining Wall	150	36	450	Yes	Yes	\$40,000	n/a	Poor	1	Upper Tier of Wood Retaining wall, tree has dislodged wood members. Difficult location to access due to the horizontal slat fencing above and the incline/vegetation below; possible repair location?

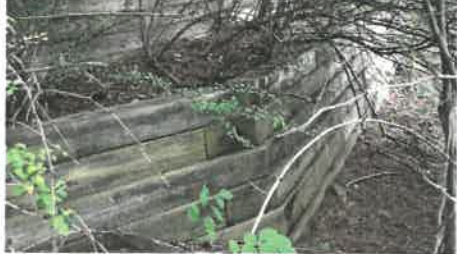
20.B	Retaining Wall	150	36	450	Yes	Yes	\$40,000	n/a	Fair-Poor	2	Lower Tier of wood retaining wall, is in difficult location to access due to fencing above and incline/vegetation below

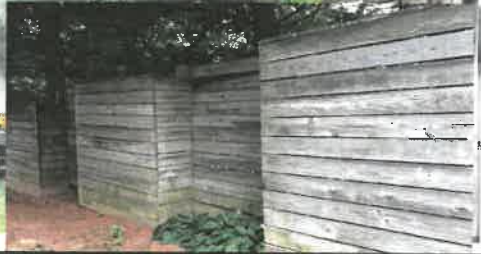
21	Fencing	750	96	6,000	Possible	n/a	See next Sheet	n/a	Fair	n/a	Horizontal Slat Fencing, typically located at edge of buildings, along Great Seneca Highway; some loose and missing board to be resecured/replaced; there are select areas with Graffiti painted on the exterior side.

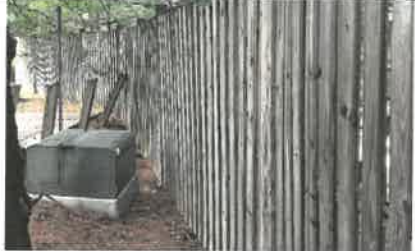
22	Fencing	285	96	2,280	Possible	n/a	See next Sheet	n/a	Fair	n/a	Shadow Box Style Fence, typically located at ends of streets; located along Great Seneca Highway; some loose boards/sections to be resecured/replaced.
