REPAIR & REPLACEMENT RESERVE REPORT

AMBERFIELD HOMEOWNERS ASSOCIATION

Project #310040

DATE OF DRAFT REPORT: AUGUST 16, 2010

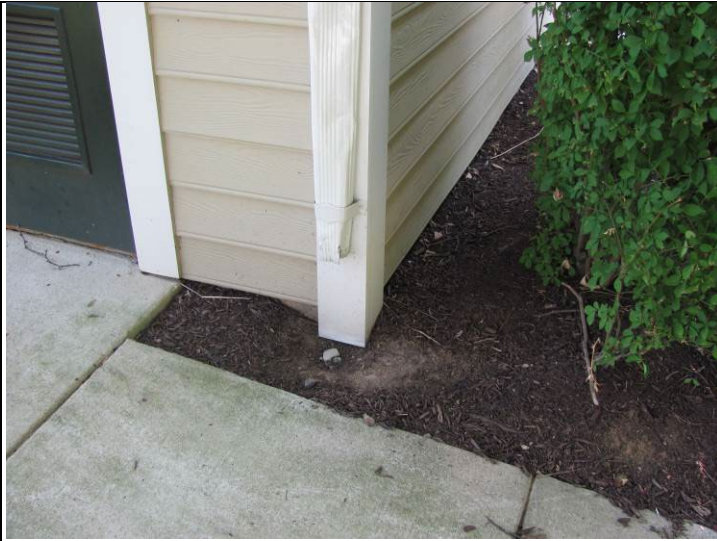
1. It was noted that on the front left side of the pool house the downspout boot is missing and causing minor erosion. We recommend that a new boot for the downspout be installed. (see photo #1)

Photo #1: Downspout boot missing

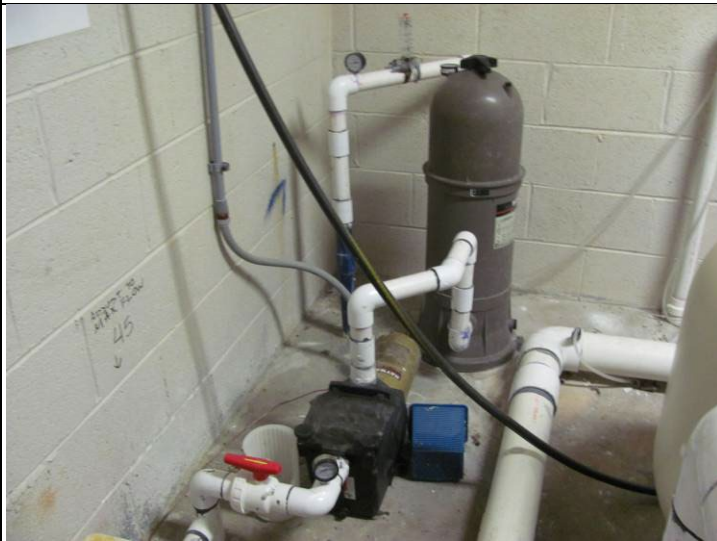
Photo #2: Pool filter system for wading pool

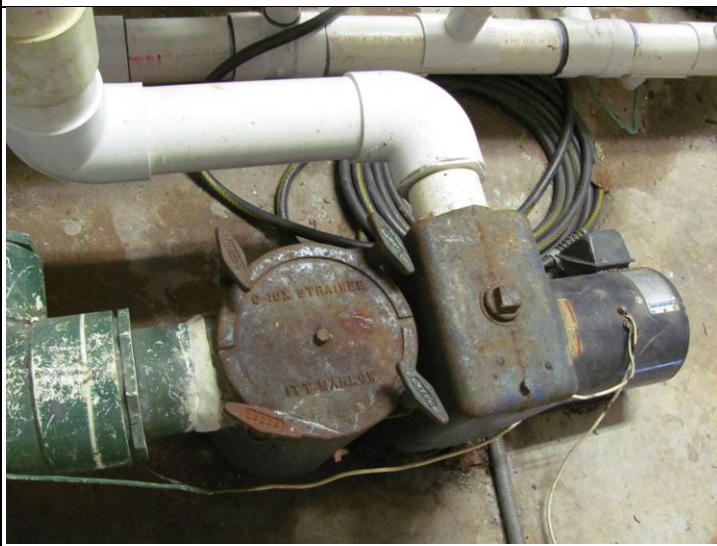
Photo #3: Main pool pump

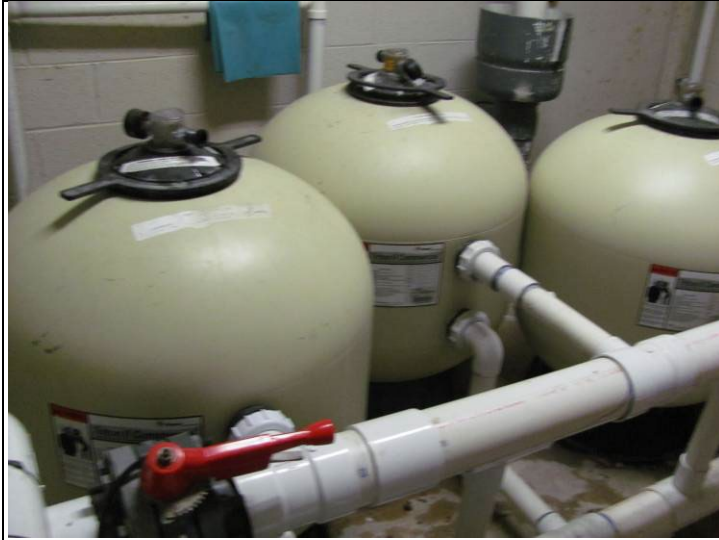
Photo #4: Main pool filter

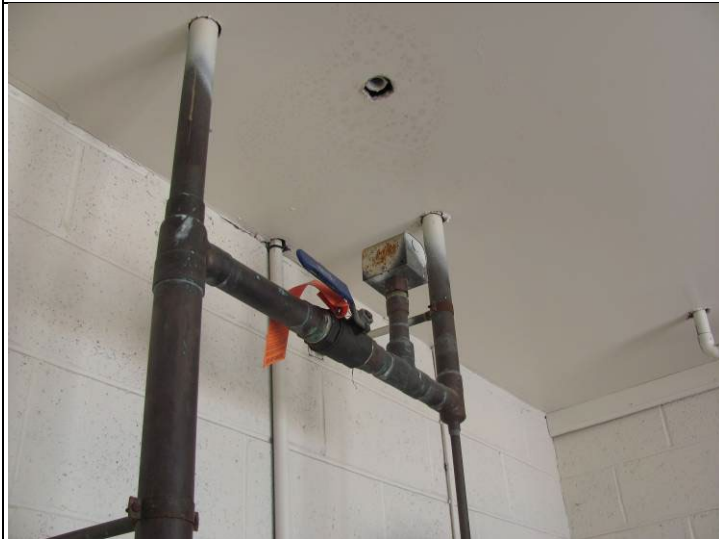
Photo #5: Pool office with sprinkler head removed

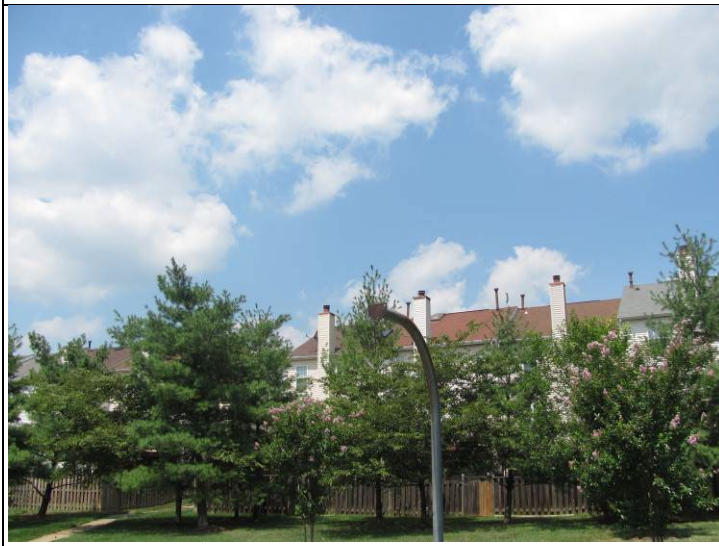
3. The basketball court is missing a back board and hoop as well as some damage to the surface. If the owners wish to have a basketball court these will require repair. (see photos #6, 7, 8 & 9)

Photo #6: Basketball missing backboard

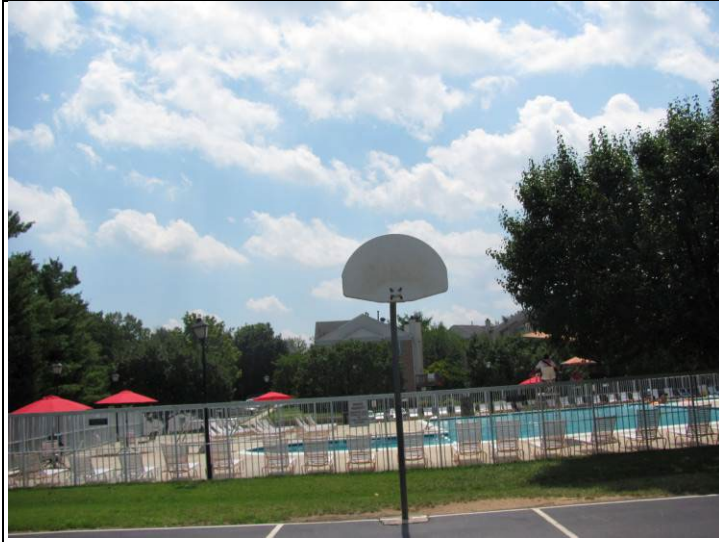
Photo #7: Basketball missing hoop

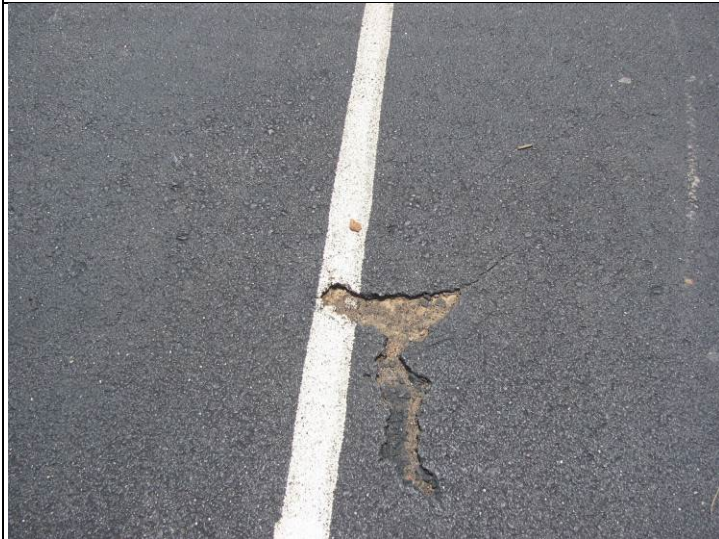
Photo #8: Basketball court damage

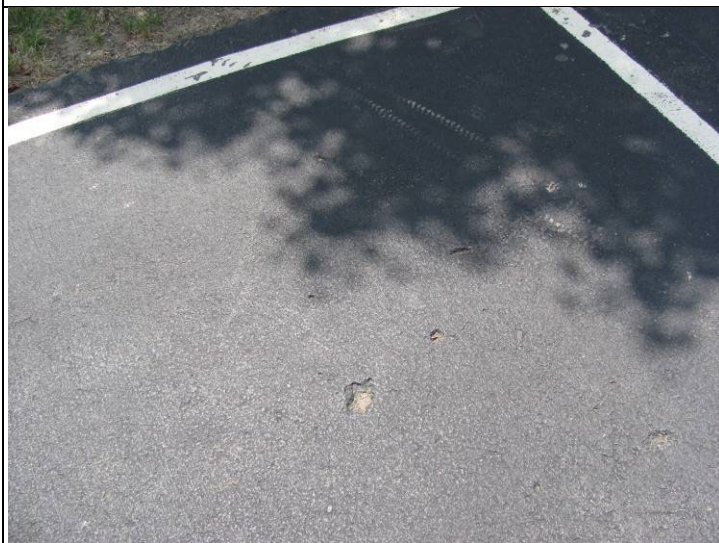
Photo #9: Basketball court damage

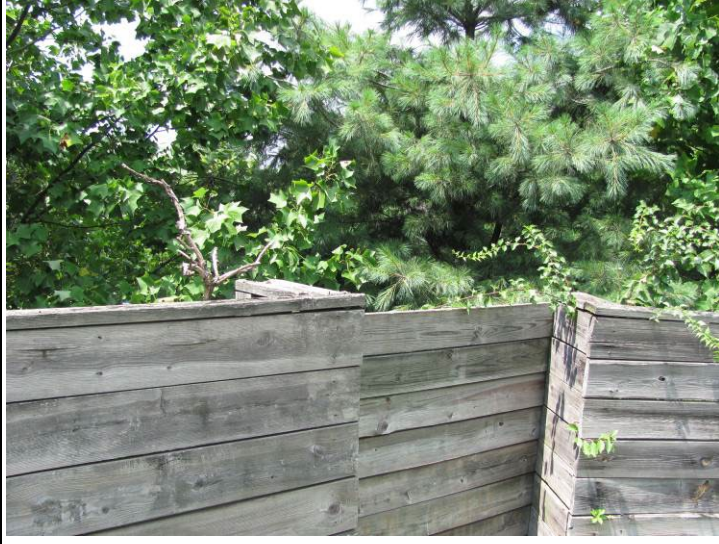
Photo #10: Wood retaining walls

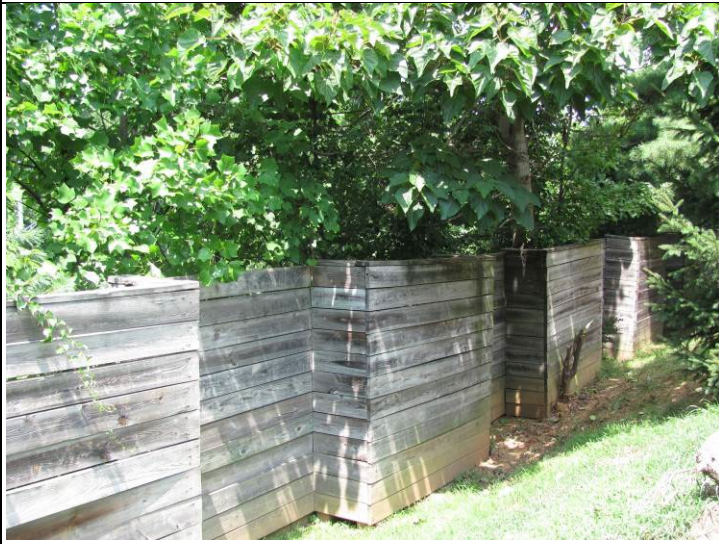
Photo #11: Wood retaining walls

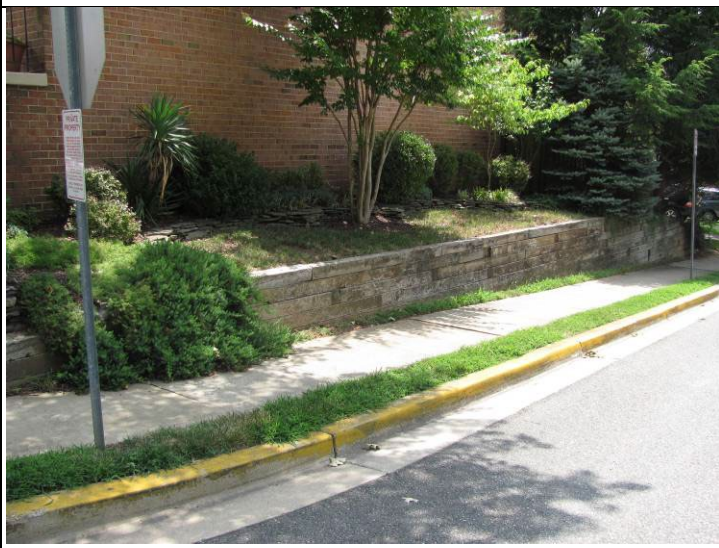
Photo #12: Wood retaining walls

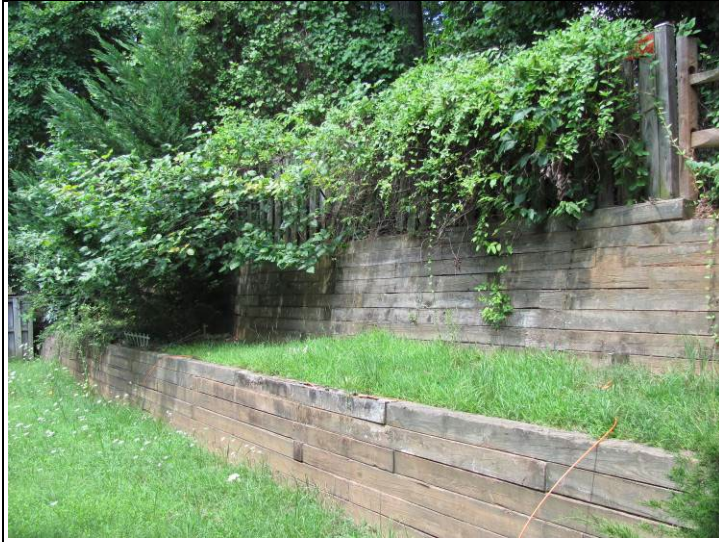
Photo #13: Wood retaining walls

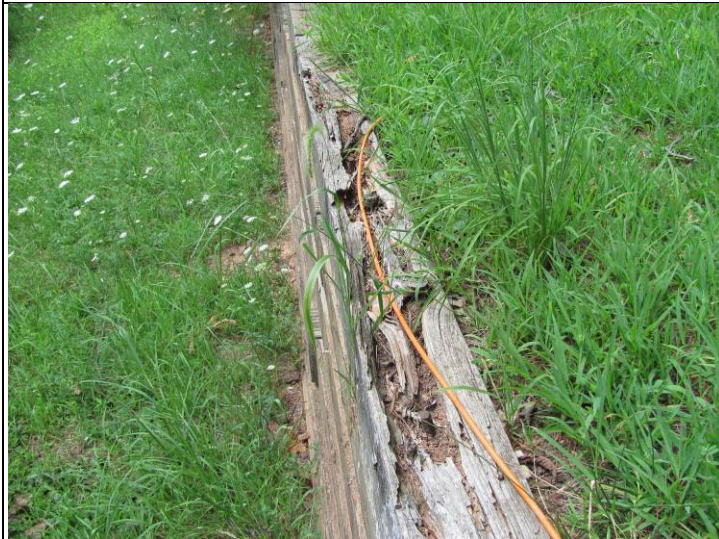
Photo #14: Wood retaining walls

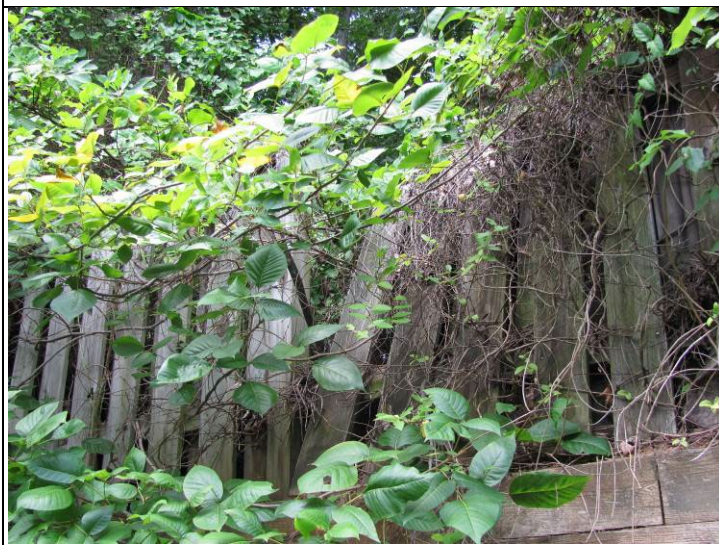
Photo #15: Wood fence

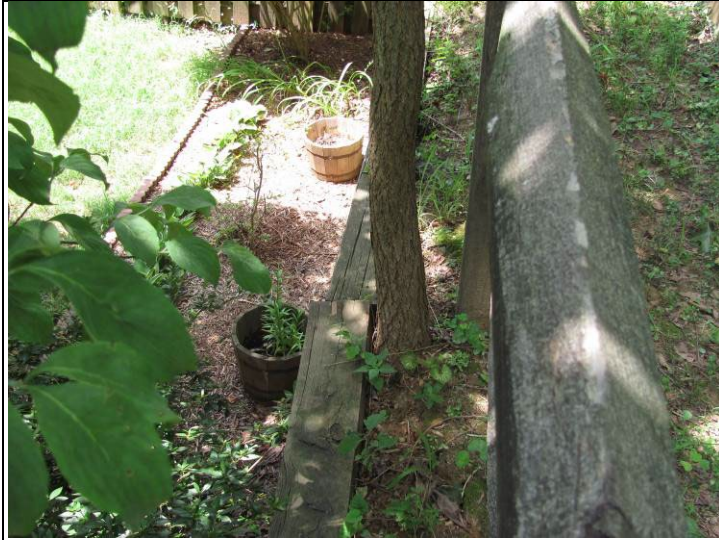
Photo #16: Wood retaining walls

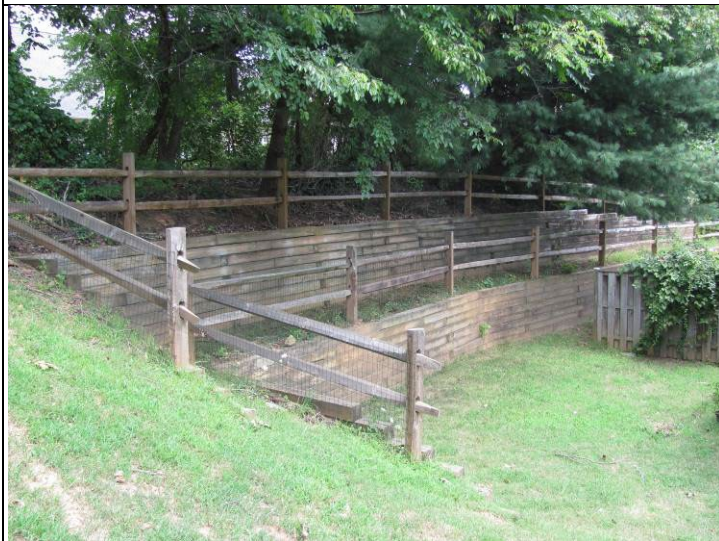
Photo #17: Wood retaining walls and fence

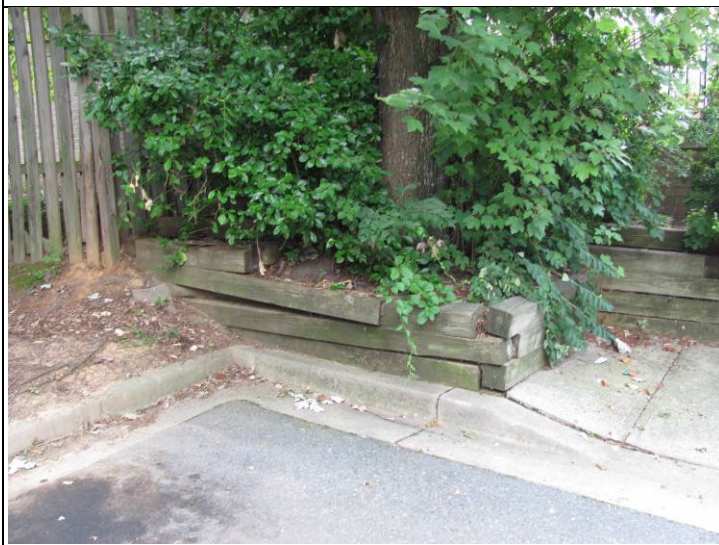
Photo #18: Wood retaining walls

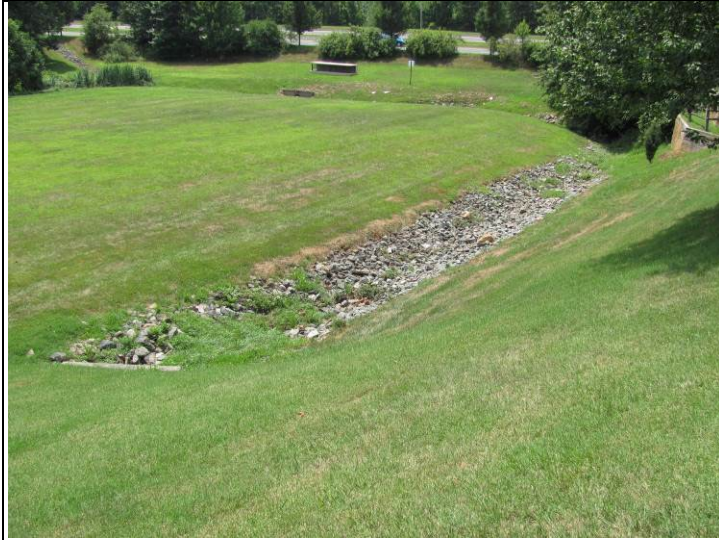
Photo #19: Rip rap area covered under storm management

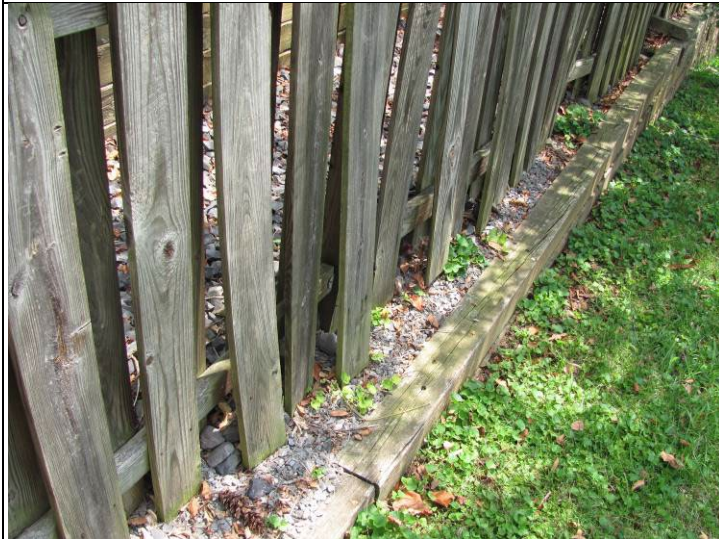
Photo #20: Wood fence

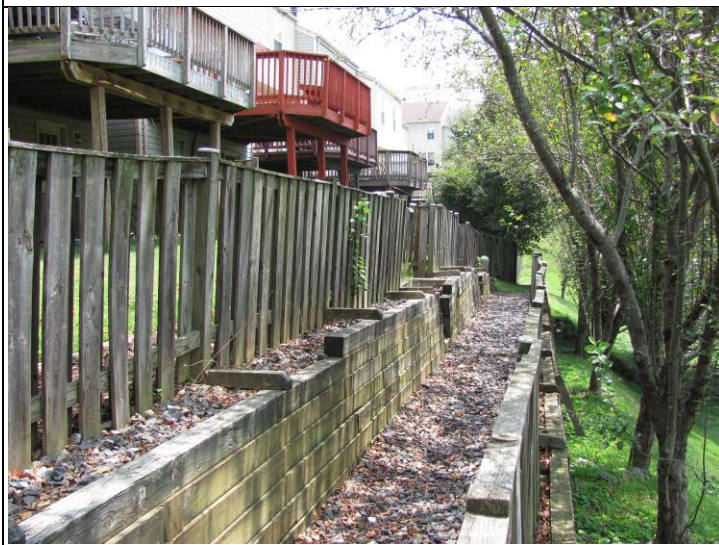
Photo #21: Wood fence and wood retaining walls

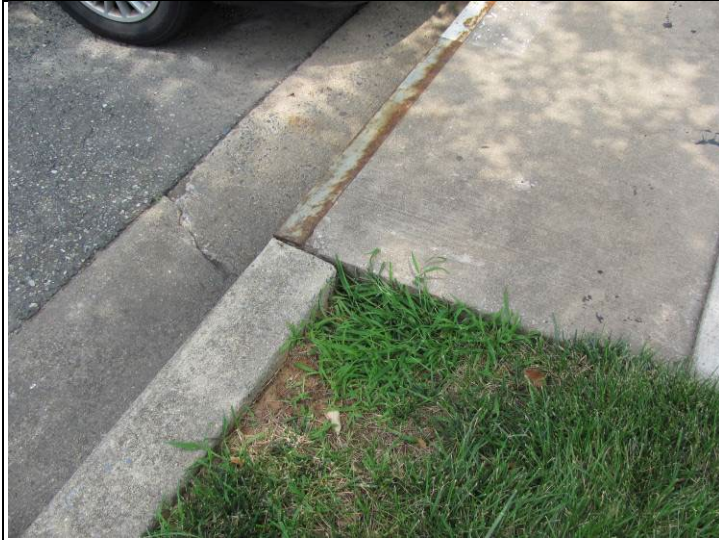
8. It was noted that some of the fire curbs painted finish is deteriorated and should be considered for refinishing.
9. At 412 Twisted Stalk Drive there is a sink hole by the concrete curb drain box. We recommend this be filled with earth to prevent a hazardous condition.

Photo #22: Sink hole by drain curb

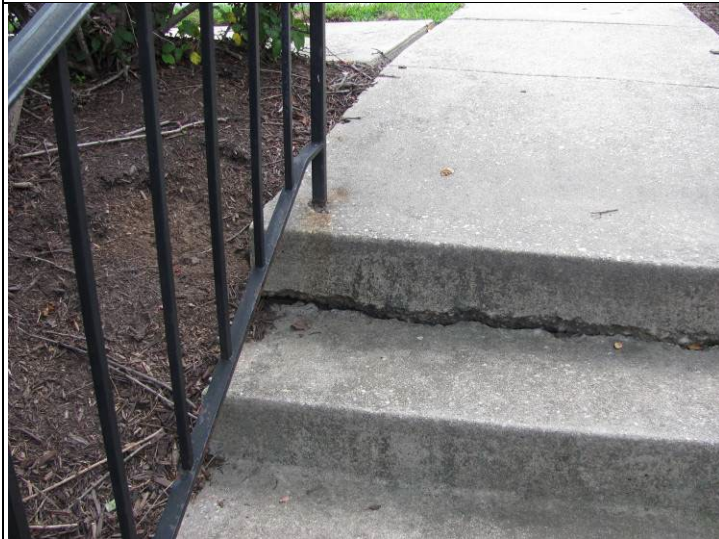
Photo #23: Stair system settling

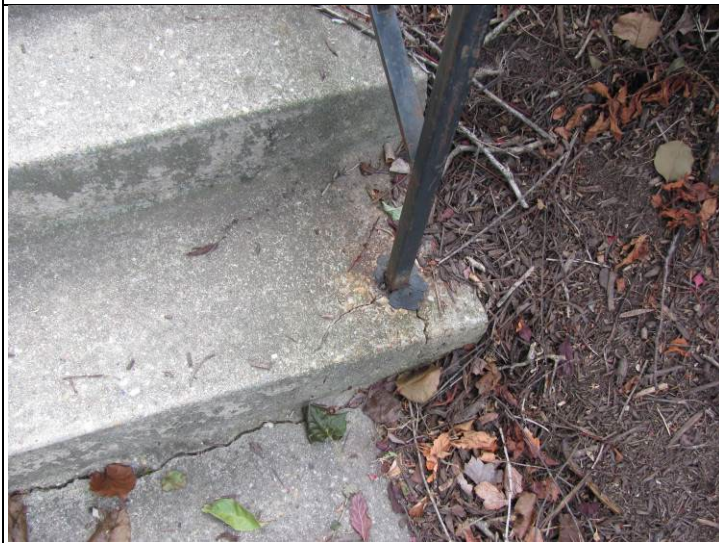
Photo #24: Stair post set depressed

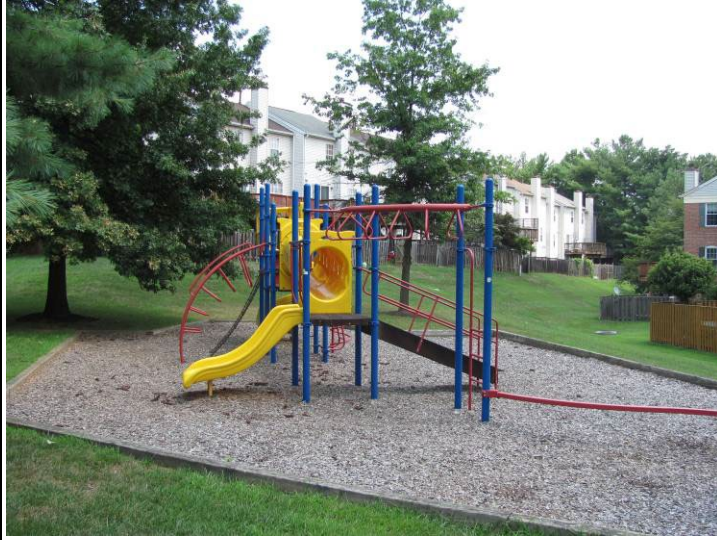
Photo #25: Tot lot

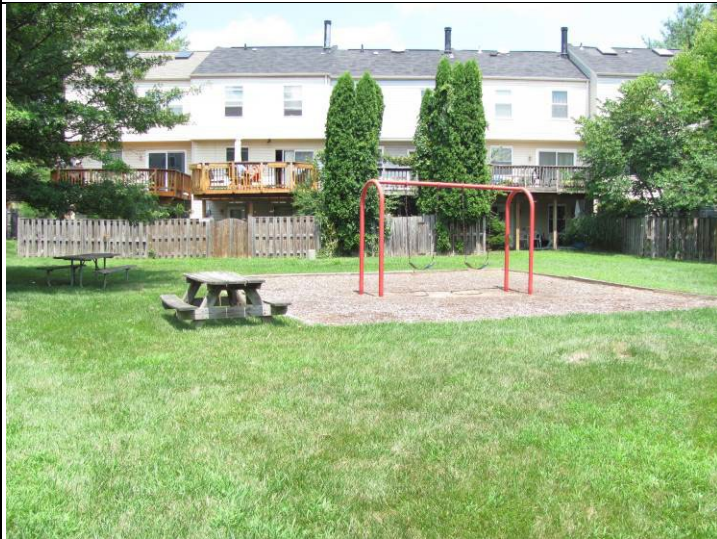
Photo #26: Tot lot

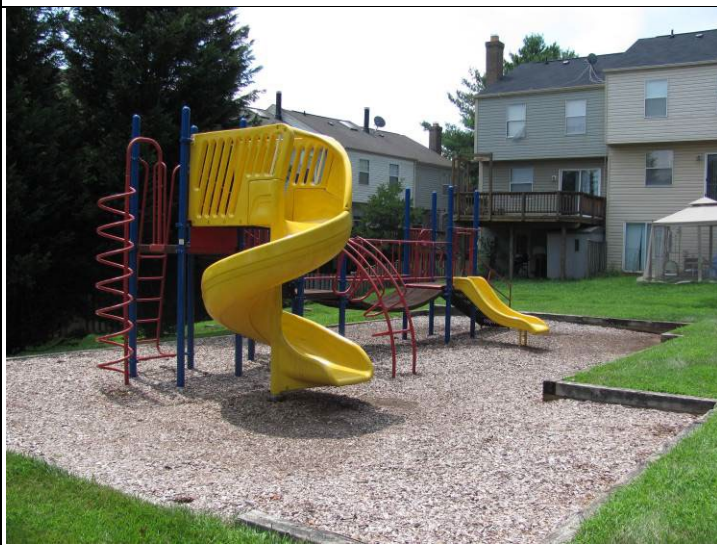
Photo #27: Tot lot

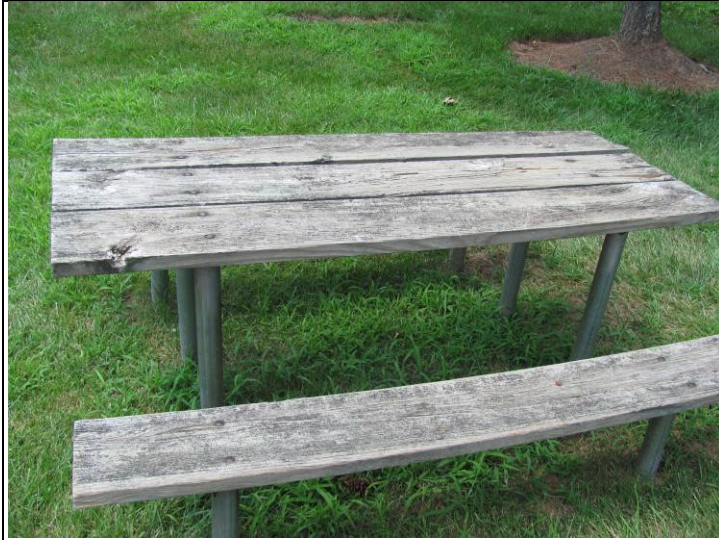
Photo #28: Picnic table

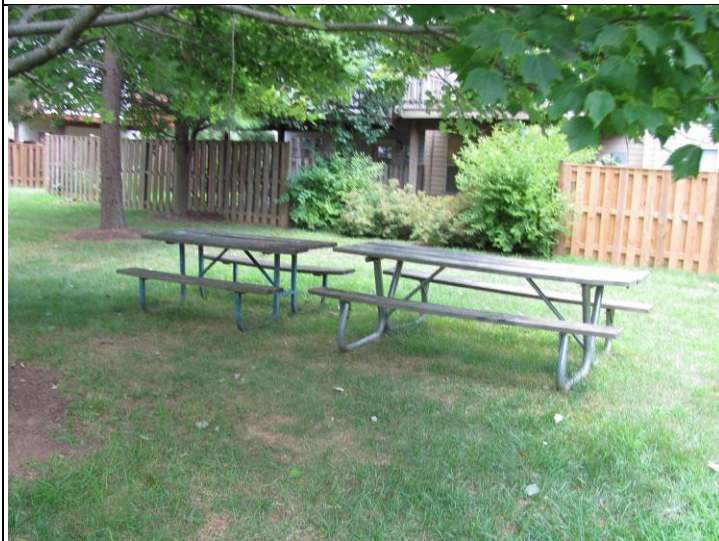
Photo #29: Picnic tables

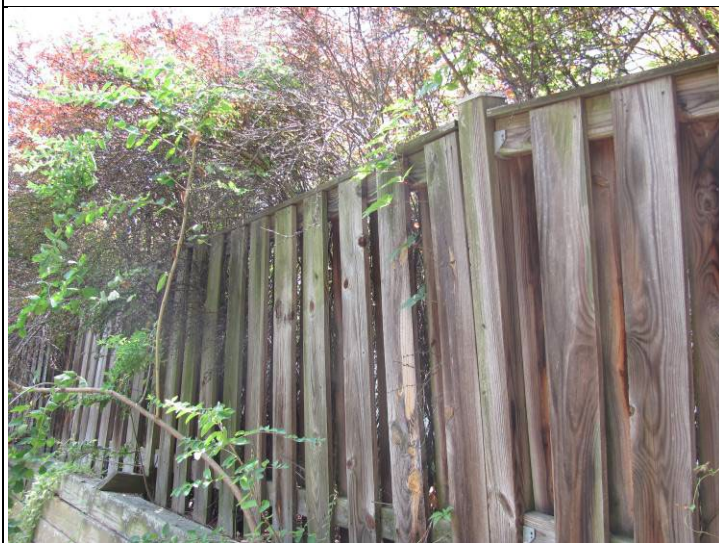
Photo #30: Wood fence
