REPAIR & REPLACEMENT RESERVE REPORT

AMBERFIELD HOMEOWNERS ASSOCIATION

Project #315084

DATE OF DRAFT REPORT: AUGUST 22, 2016

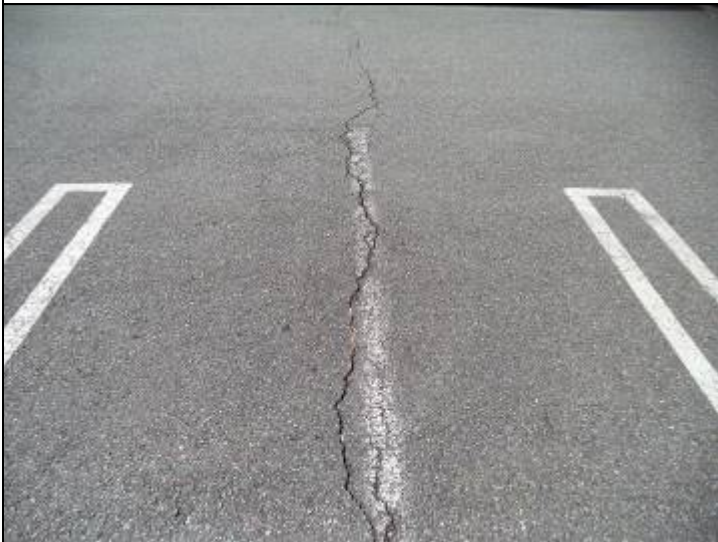
Photo #2: There is a crack in the asphalt surface at the pool area, which we recommend be sealed with a hot liquid asphalt material.

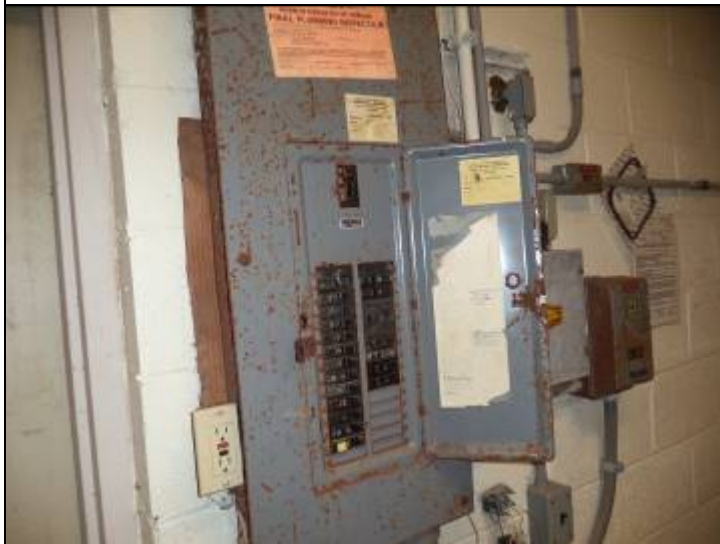
Photo #5: The electrical circuit panel box is oxidizing, which is not unusual in the high humidity pump rooms for pools. This should be monitored to ensure that a safe condition is maintained.

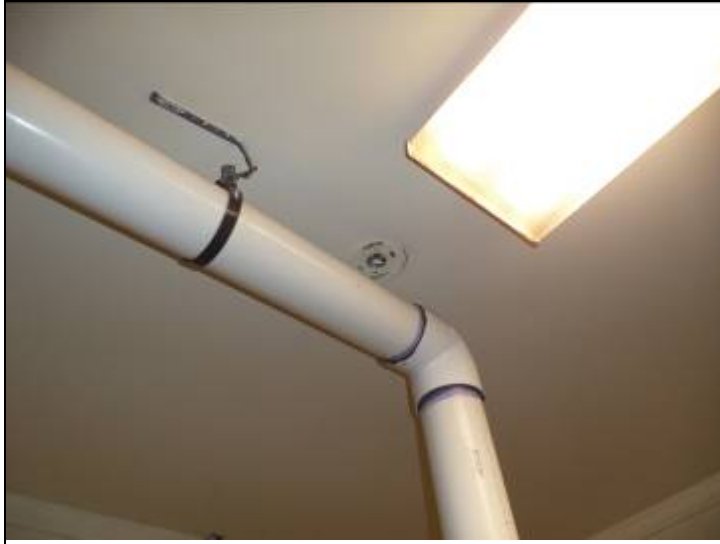
Photo #7: The smoke detector in the pump room has been removed. We recommend that this be reinstalled.

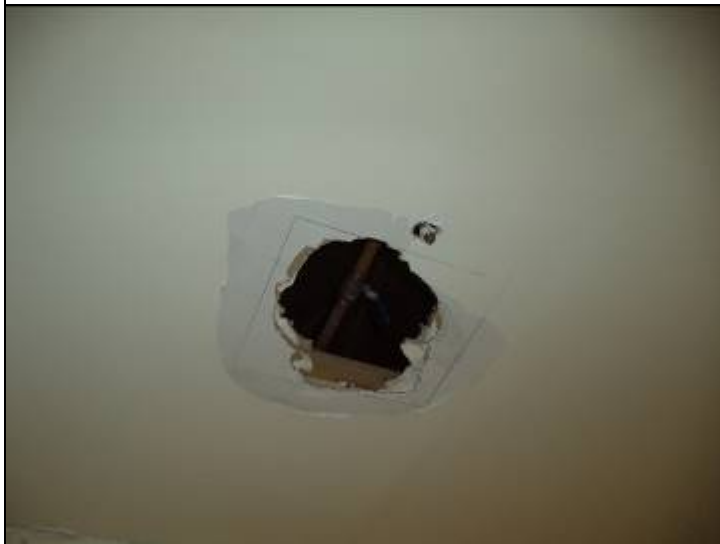
Photo #8: There is an open ceiling in the pool pump room where a domestic isolation valve has been installed. A proper access panel should be installed this location.

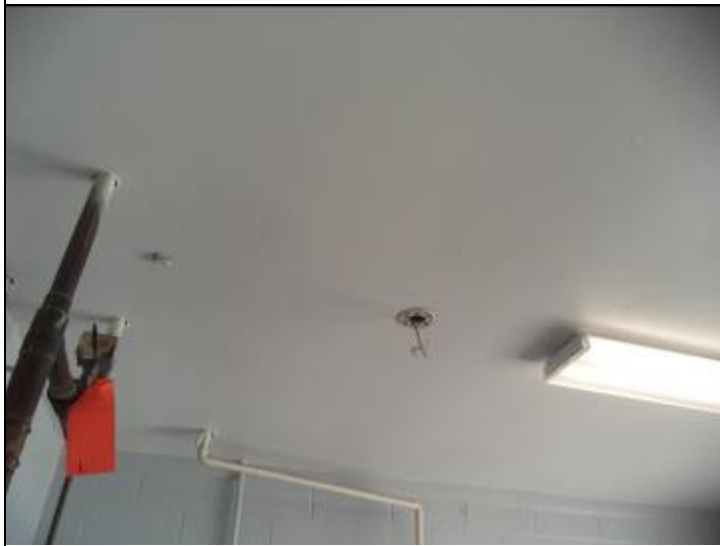
Photo #12: These mount has been removed from the pool house guard office.

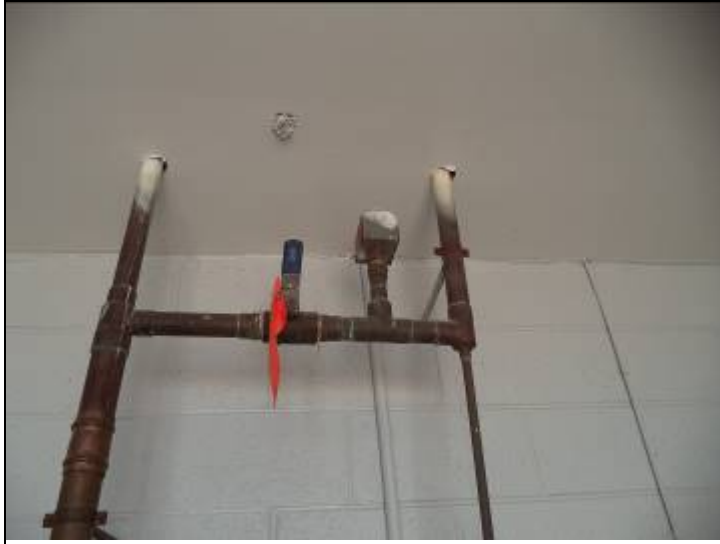
Photo #13: The sprinkler system for the pool house has been isolated, and the heads have been removed.

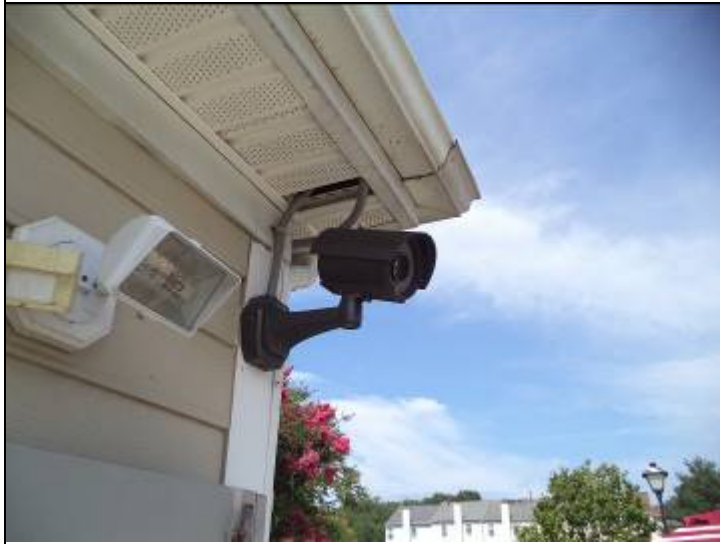
Photo #14: New camera systems have been added to the pool house building.

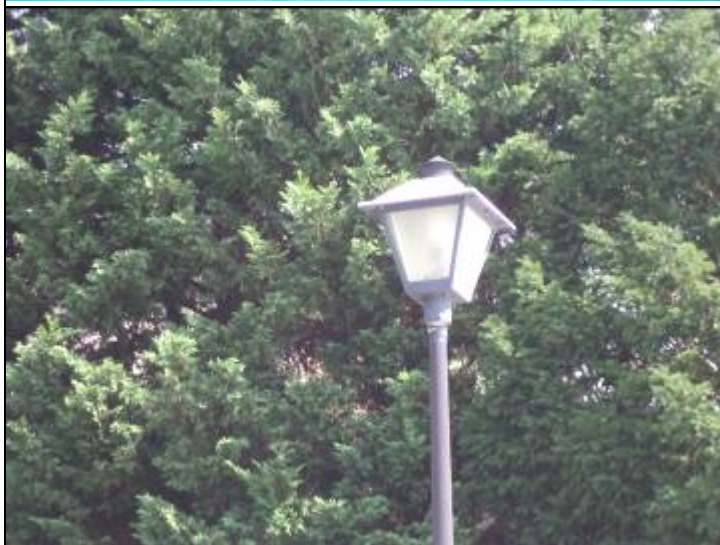
Photo #18: The light fixtures are still operational. However, the finish of the fixture heads are worn and should be refinished.

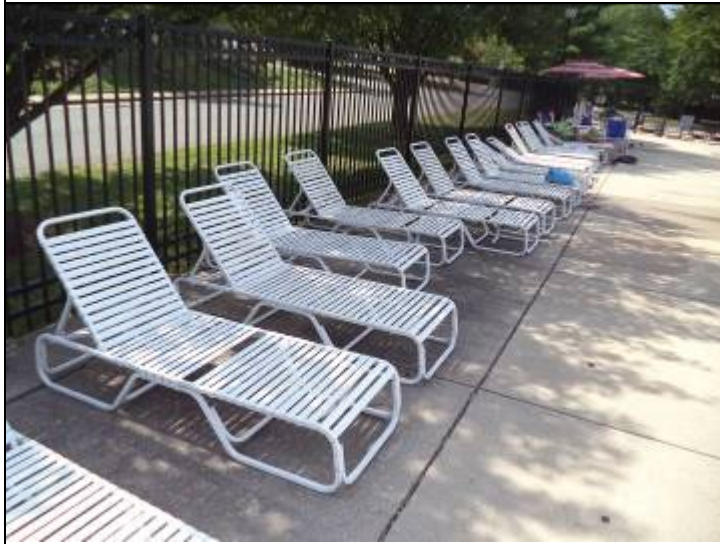
Photo #20: We noted several with damaged slats on the lounge chairs. These should be refurbished or new furniture should be scheduled.

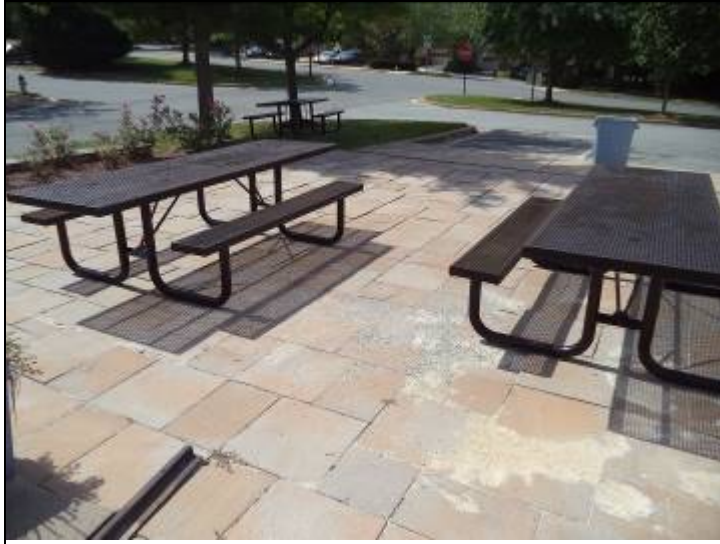
Photo #22: The picnic tables at the side of the pool house have been included in the reserve as part of the pool furniture. Some deterioration to the protective coating of the metalwork was noted.

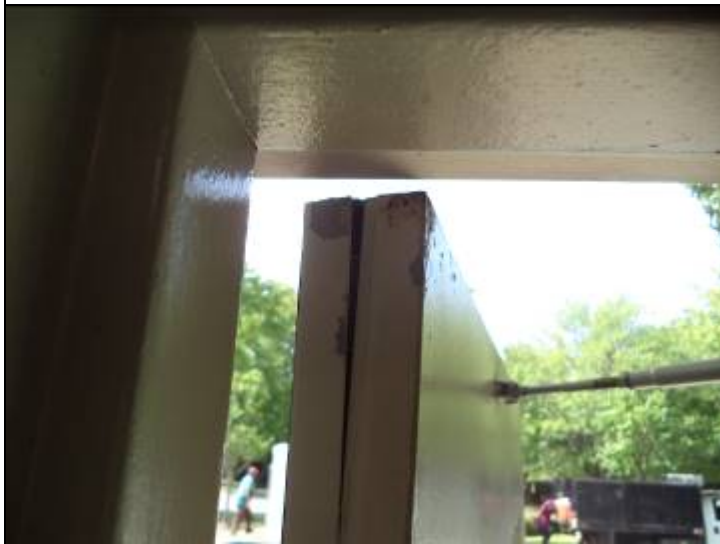
Photo #23: The entry door at the pool house is damaged where the metal is splitting. This should be sealed to retard deterioration.

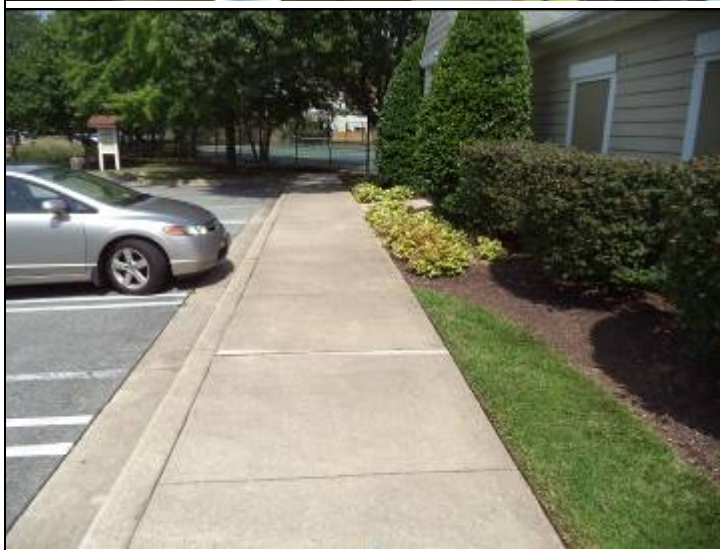
Photo #24: The management committee has had the concrete in some areas ground to prevent trip hazards.

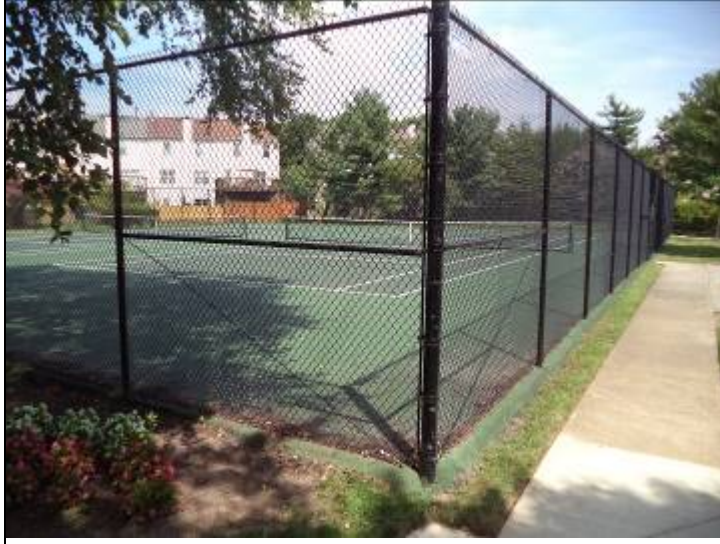
Photo #25: The tennis court fence has been refurbished as well as the tennis courts.

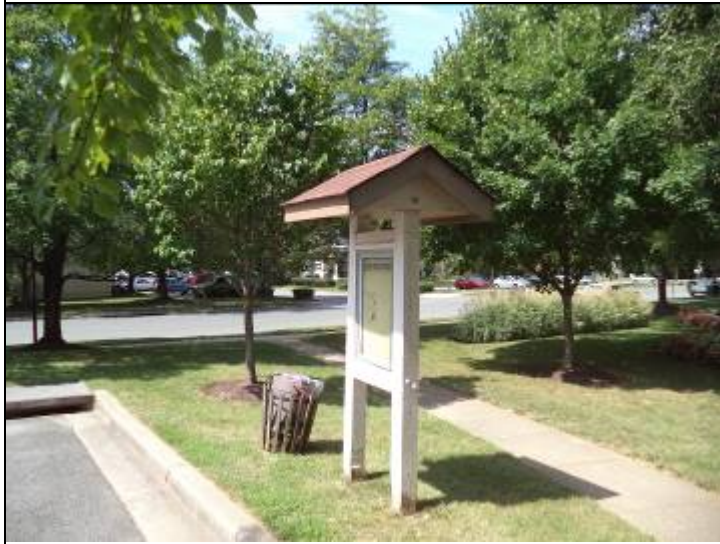
Photo #26: The bulletin signboard at the pool area is included in the reserve as site signs.

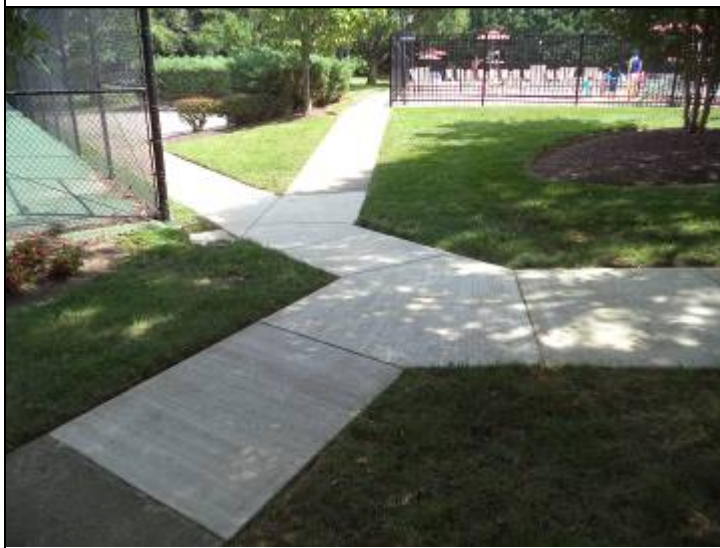
Photo #27: Management has replaced some of the damaged concrete on the property.

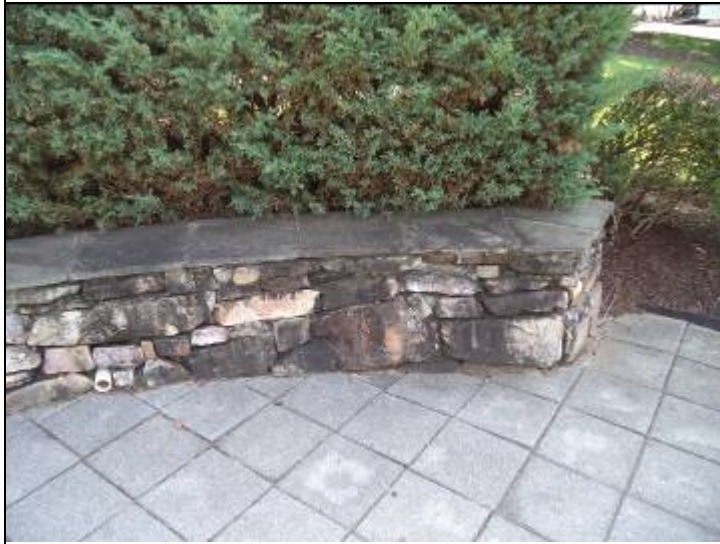
Photo #29: Consideration should be given to washing the retaining wall.

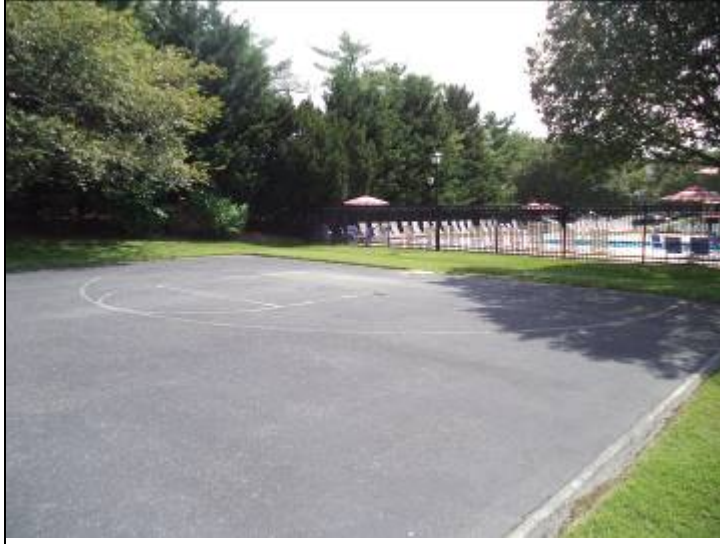
Photo #31: The basketball court has had the nets and poles removed and is no longer being used.

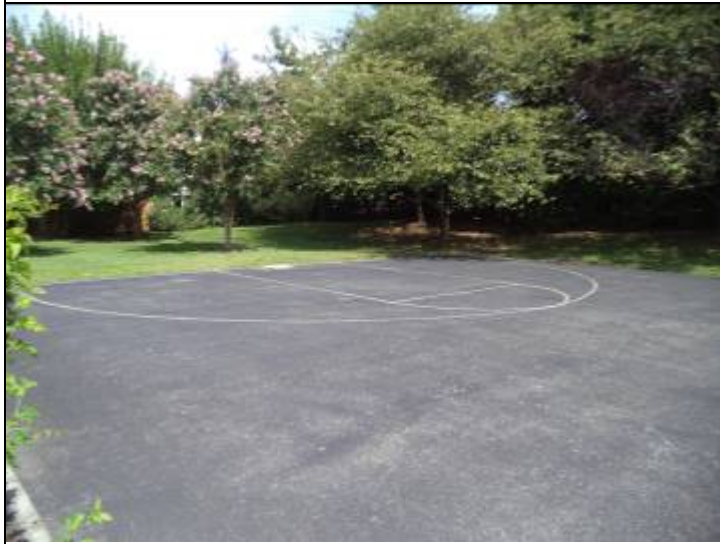
Photo #32: Other than cosmetically removing the asphalt surface, we can recommend possibly using this for additional services.

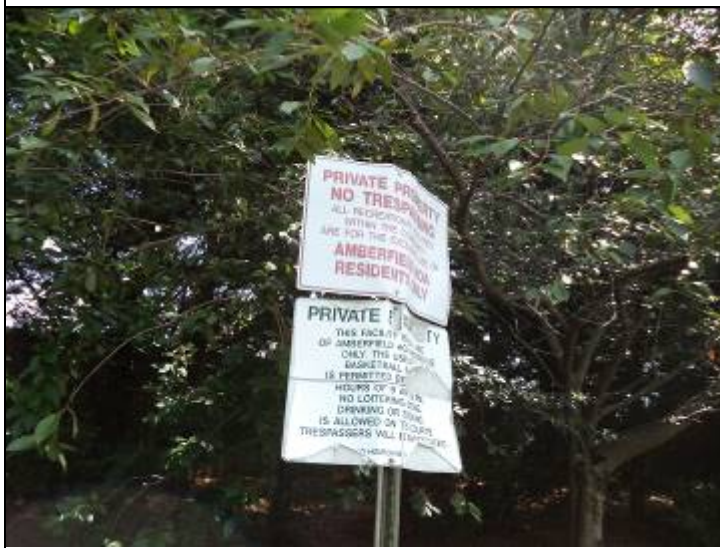
Photo #33: Some of the site signs do require replacement at this time.

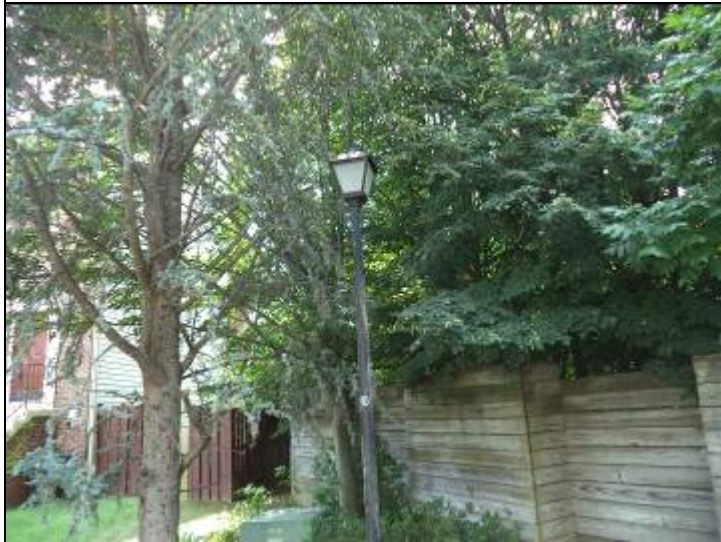
Photo #35: Site light fixtures are maintained by the utility.

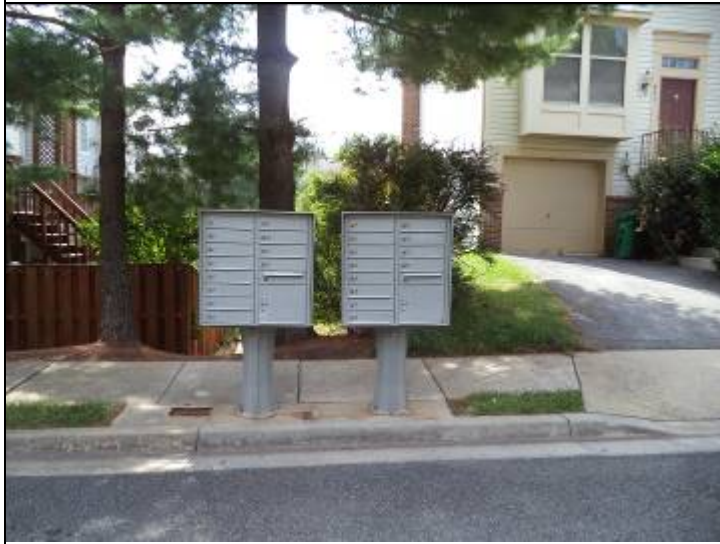
Photo #38: Some of the mailboxes on the site have been replaced.

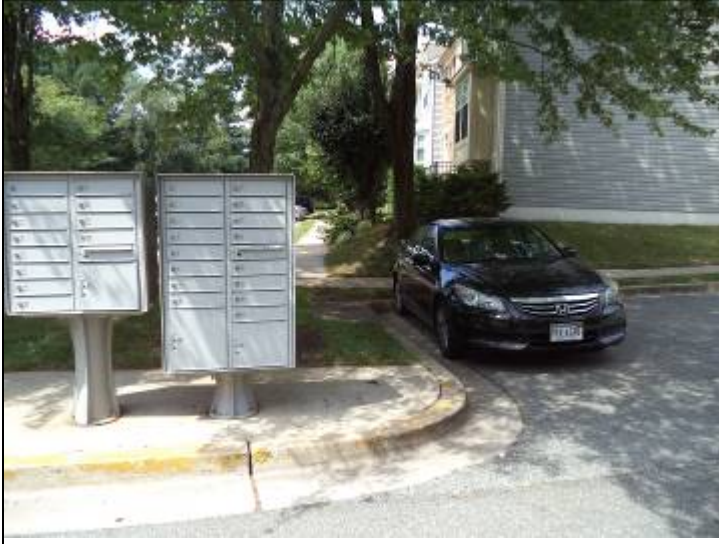
Photo #40: Some of the mailboxes on the site have been replaced.

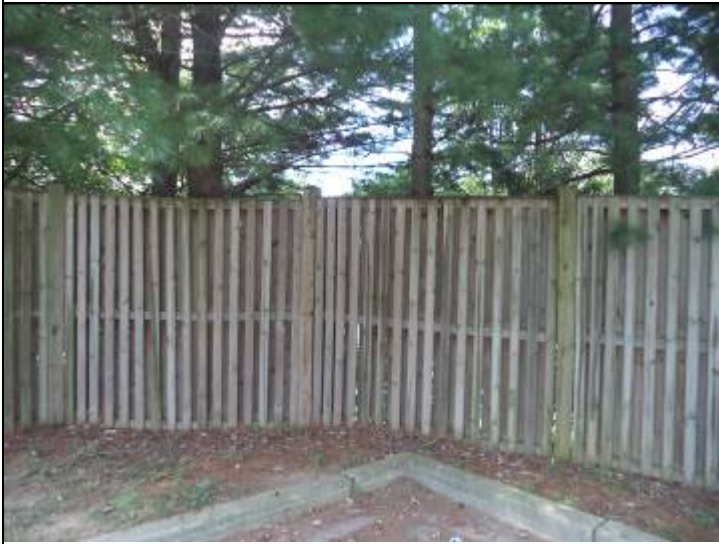
Photo #41: The sound wall fence has had repairs made in a few areas.

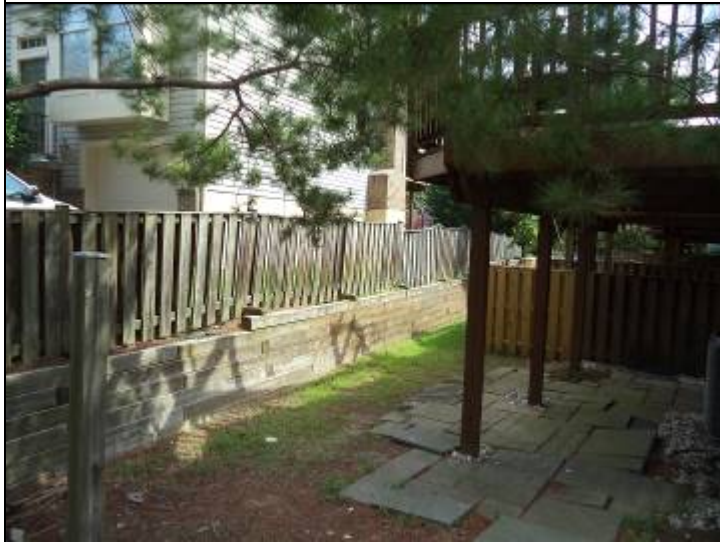
Photo #44: Some of the fences on top of the walls and some of the walls are deteriorated. These require repairs and restoration.

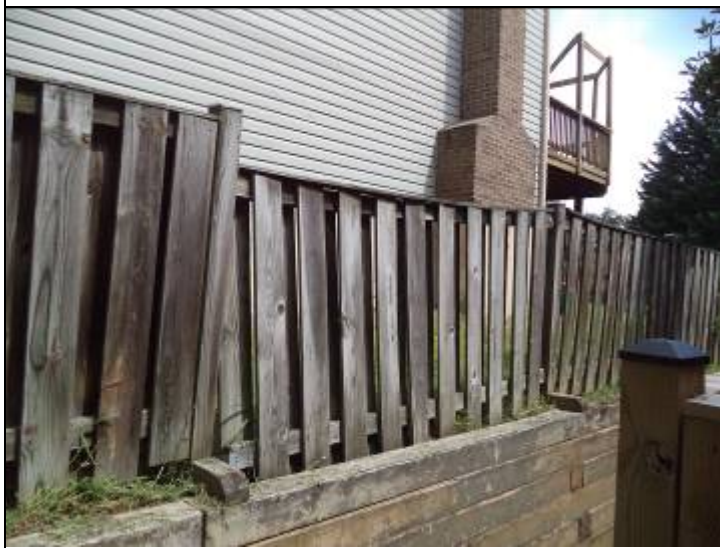
Photo #45: Some of the fences on top of the walls and some of the walls are deteriorated. These require repairs and restoration.

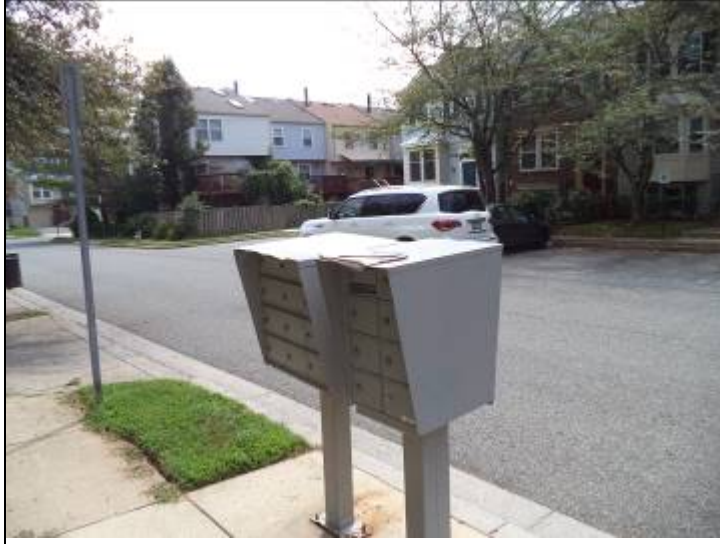
Photo #46: Some of the mailboxes on the property are original.

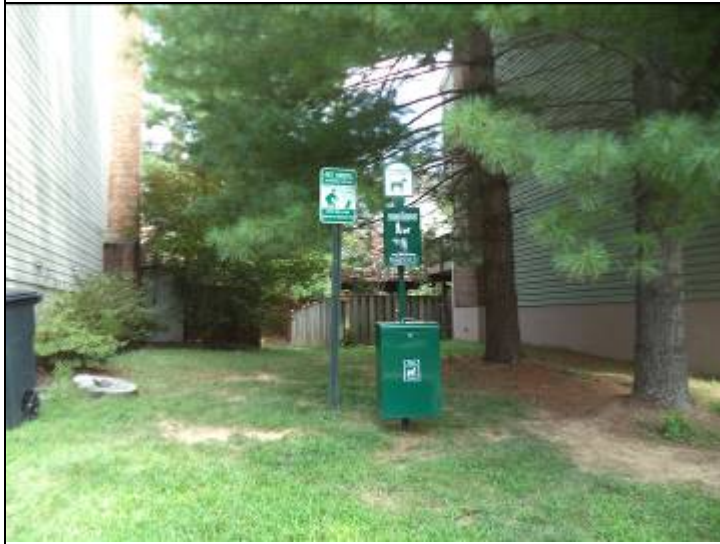
Photo #47: Dog stations have been added to the property.

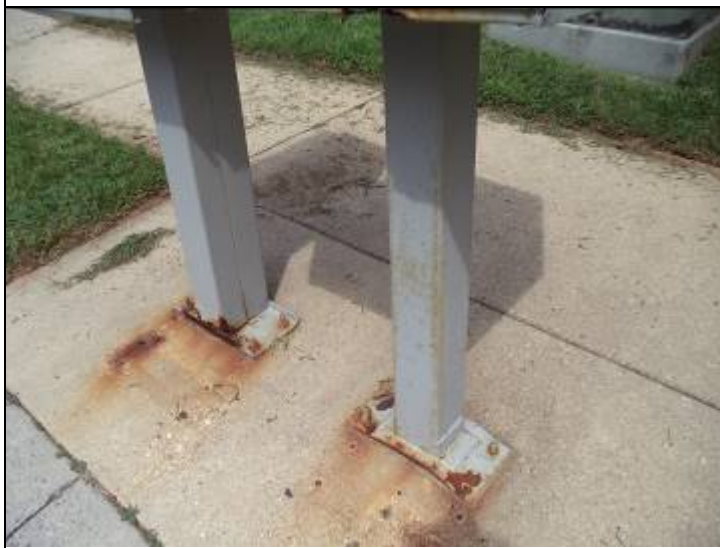
Photo #48: Some of the original mailboxes have some deterioration of the base metal. We recommend these be addressed to prevent full deterioration.

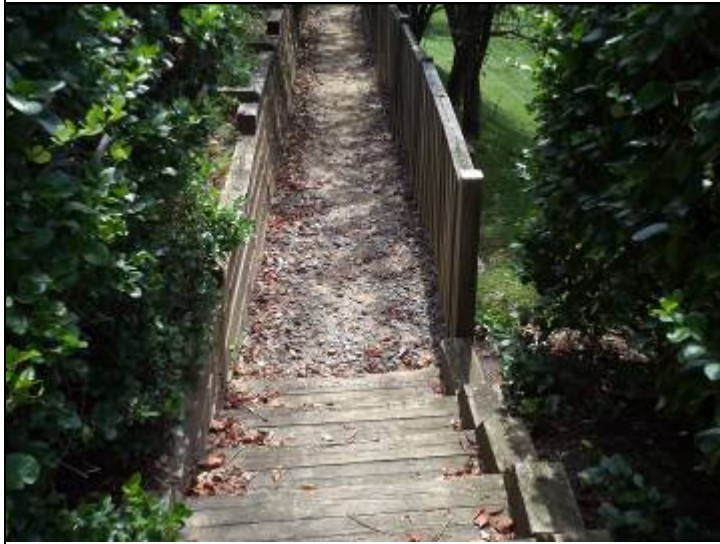
Photo #50: There is a graveled walk along the drainage field. We recommend additional gravel be added. This would be considered a maintenance issue.

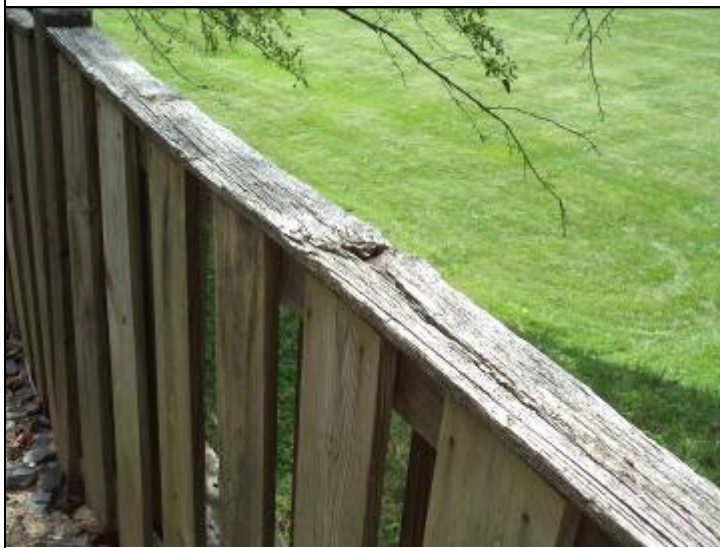
Photo #51: The fence along this will walk is deteriorated and requires repair.

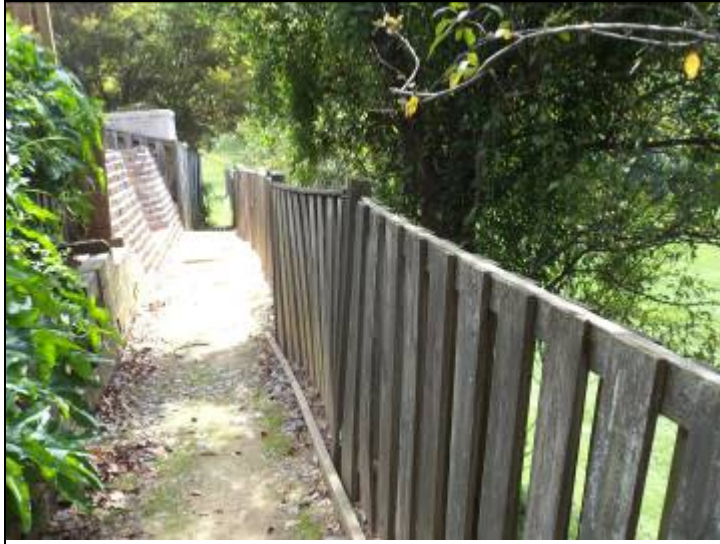
Photo #52: The fence along this walk has deteriorated and requires repair.

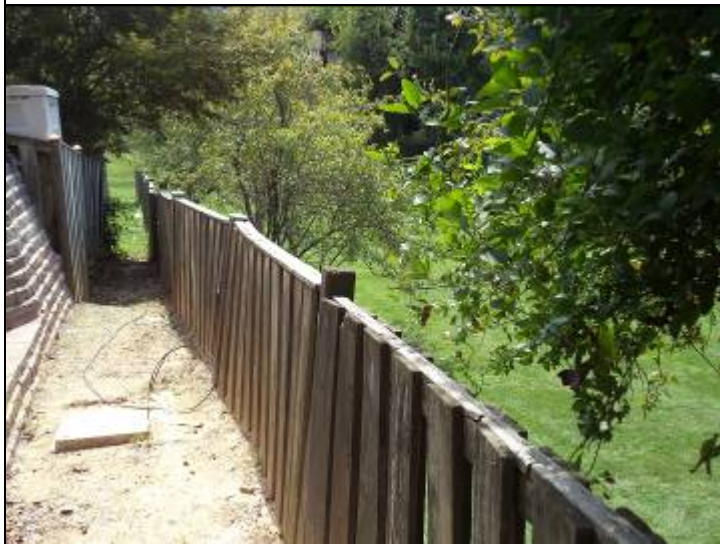
Photo #53: The fence along this walk has deteriorated and requires repair.

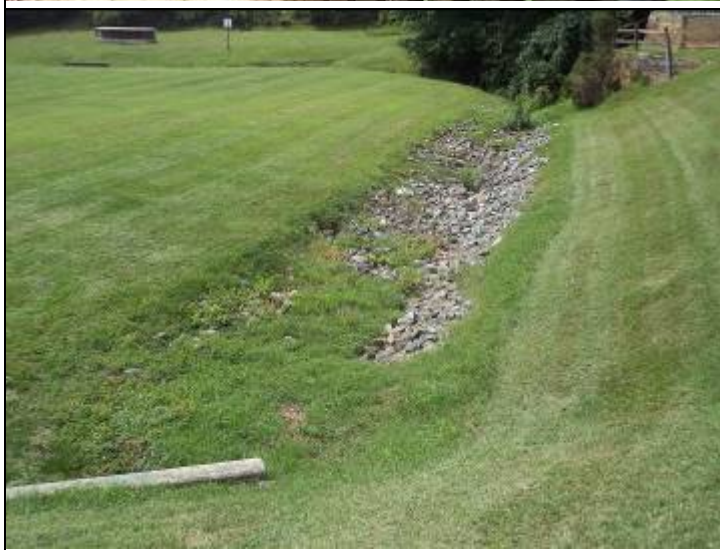
Photo #54: The riprap is starting to have some overgrowth, which will reduce the efficiency of the riprap. The riprap does require some attention.

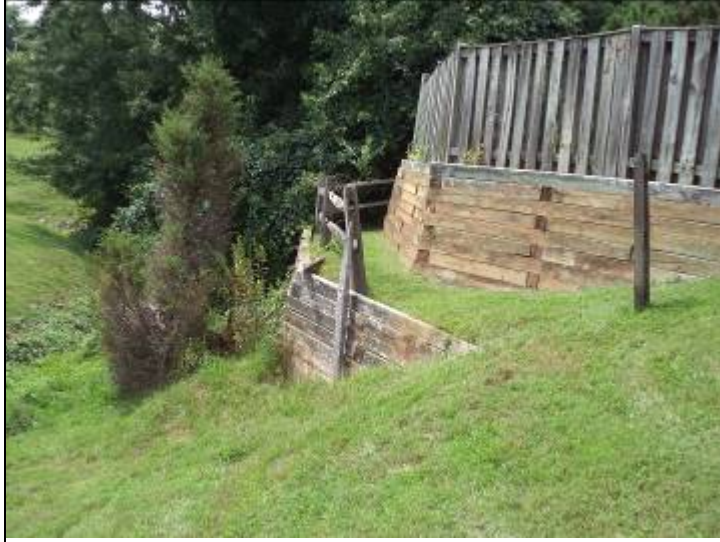
Photo #55: The split rail fence by the drainage field is damaged, and deteriorated areas require some repair.

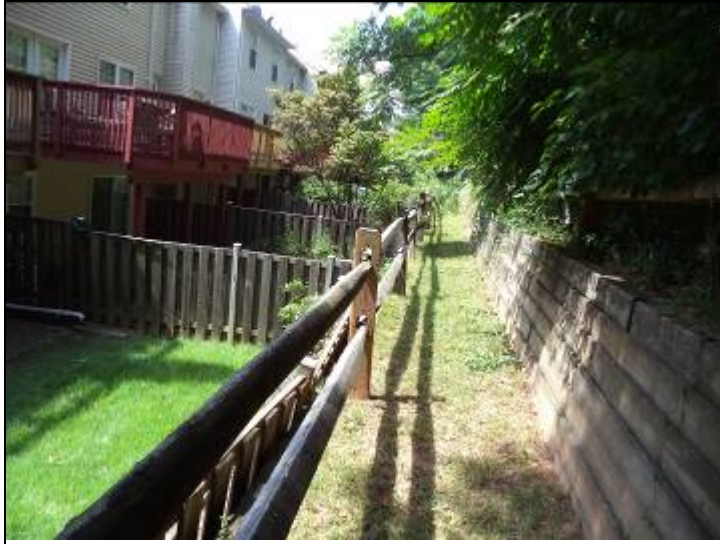
Photo #58: Some of the split rail fence has been updated.

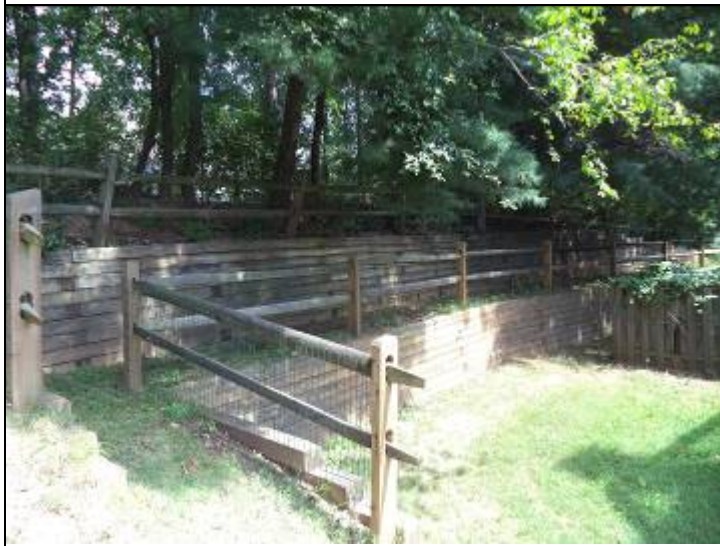
Photo #59: Some of the split rail fence has been updated.

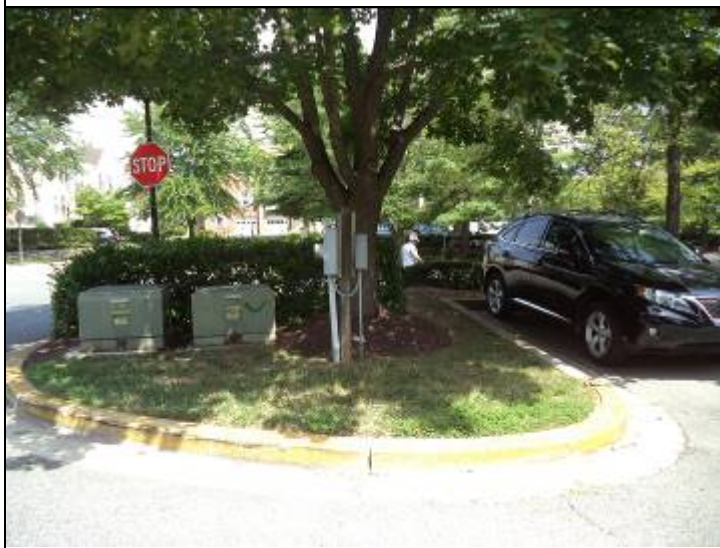
Photo #60: Electrical service for the front entrance sign lighting.
