# LEVEL 1 REPLACEMENT RESERVE REPORT FY 2020 AMBERFIELD HOA

## AMBERFIELD HOA

GAITHERSBURG, MARYLAND

March 5, 2020

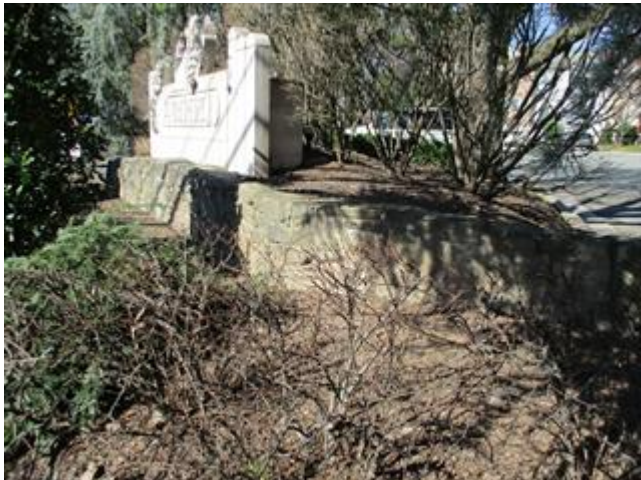
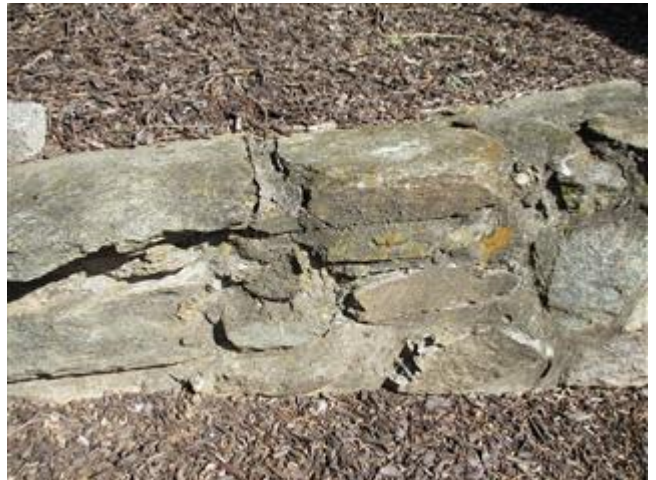
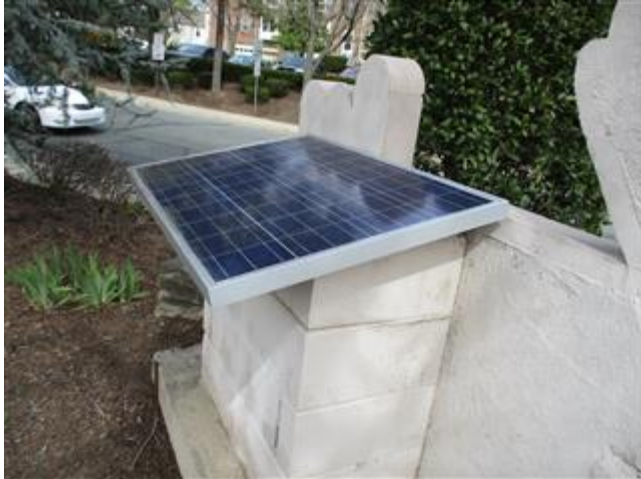
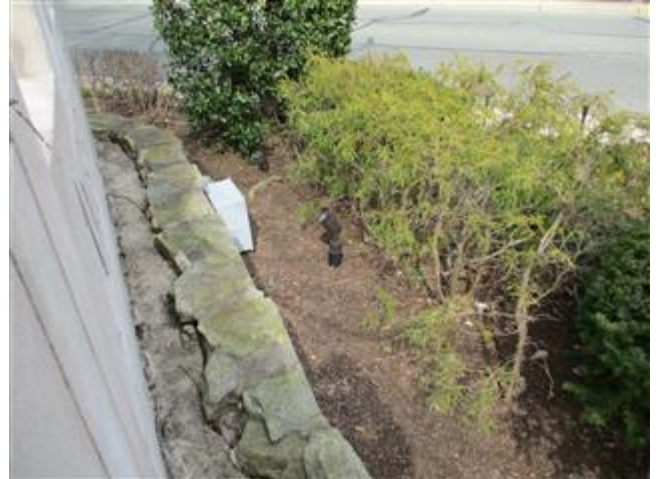
The monuments are illuminated by a 120-watt solar system with a 12 volt DC lithium 80 amp-hour rechargeable battery. There are six LED flood fixtures, and nine LED path light fixtures. The solar system was installed in 2016 with repairs in 2018 and 2019.

We recommend repointing and replacement of defective areas of the masonry as needed. The Association may want to consider applying a coating of Siloxane or another appropriate breathable sealant to mitigate water penetration and further degradation of the masonry work.

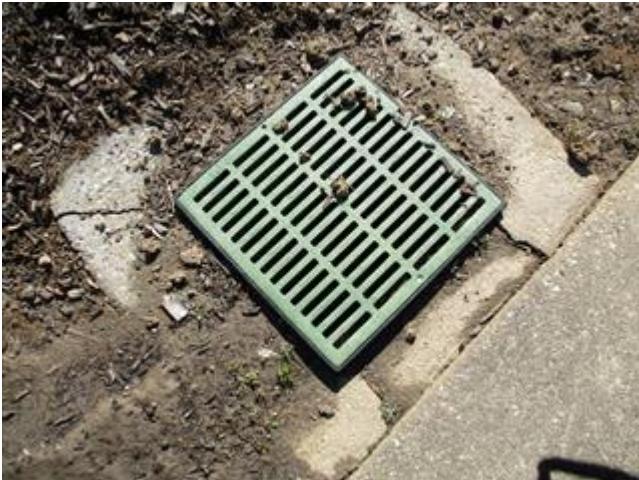
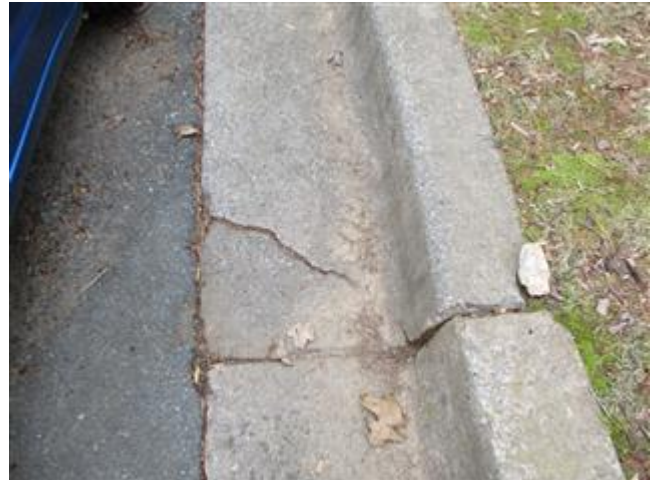
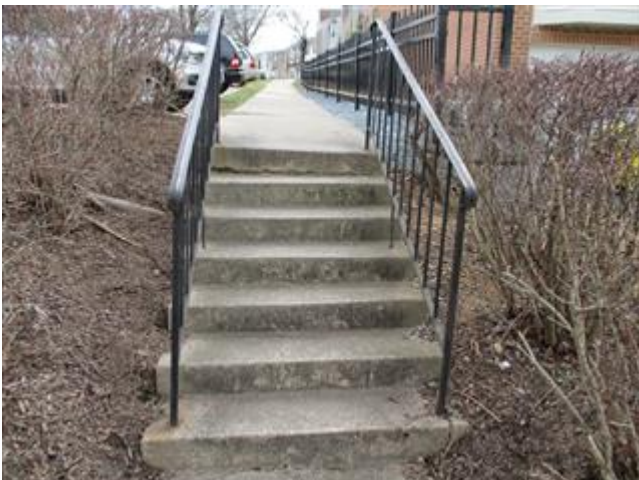
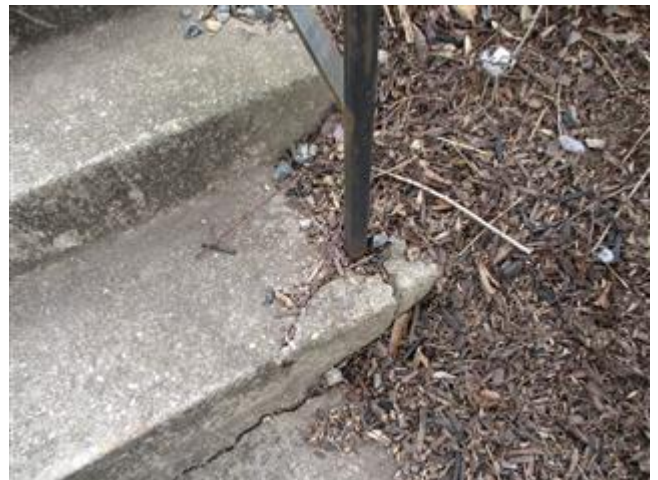
There are, however, a couple of areas in need of near term attention: (1) the concrete steps at the north end of Lazy Hollow Drive (before the hard bend left) are severely cracked, and the metal handrail is loose, and (2) the concrete aprons around two small drains near the tennis courts are cracked. See photos below.

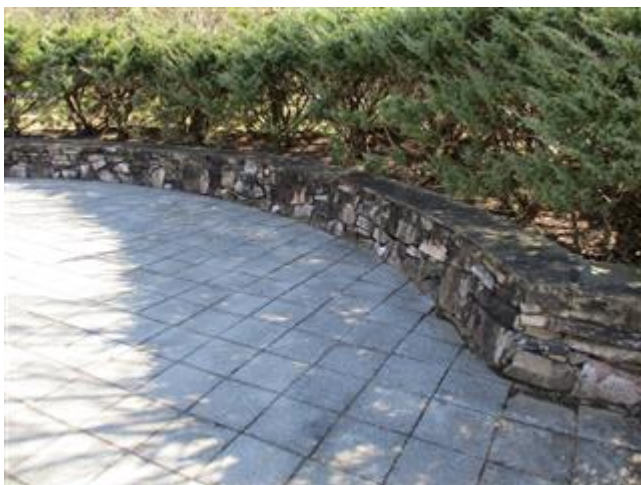
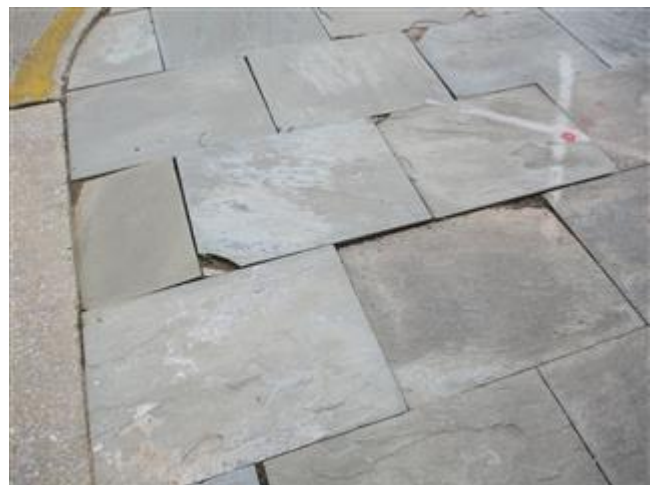
**Unit Pavers.** The Association maintains flagstone and unit paver patio areas at two locations within the community: (1) two concrete paver areas near the pool house and (2) one flagstone area at the interaction of Suffield Drive and Autumn Flower Lane. At present, the concrete paver areas are in good condition. The flagstone area, however, exhibits multiple cracks and misaligned flagstones.

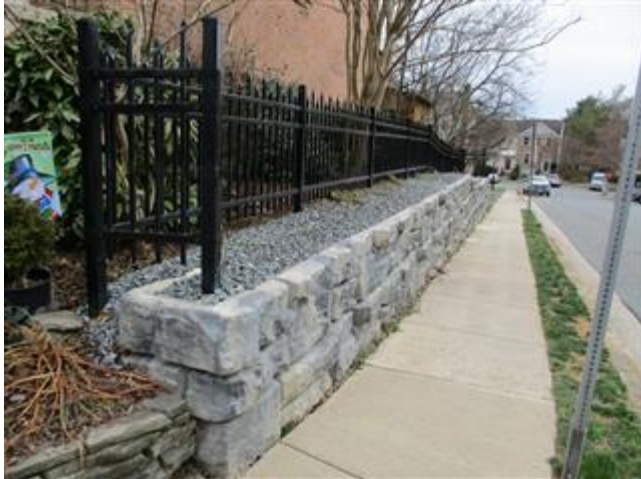
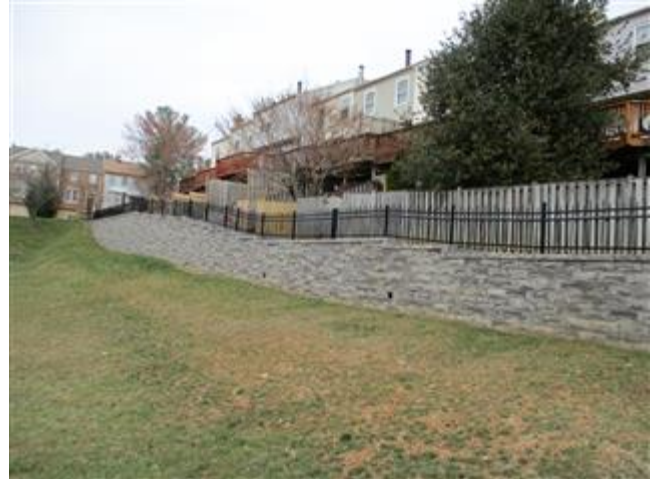
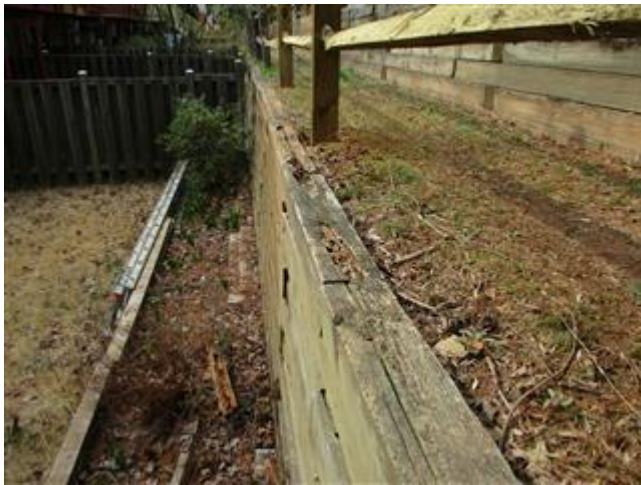
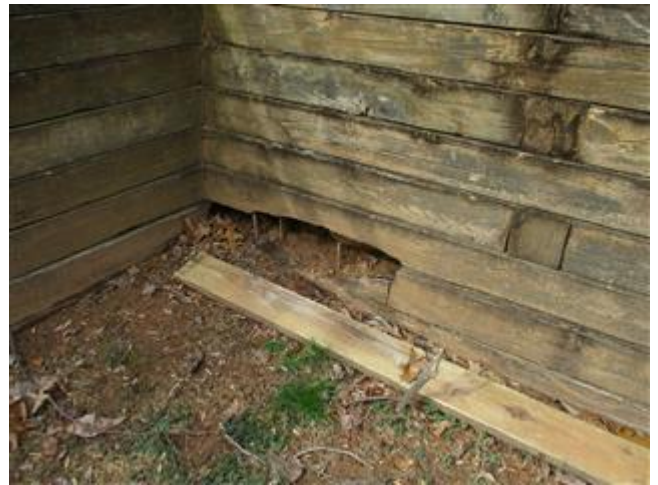
The following is an accounting of the community's 18 major retaining walls. Note that "Wall Number" refers to the wall numbers used in the Retaining Wall Project plan. Further note that Walls 11 and 16 were determined to be homeowner property and were removed from the replacement project.

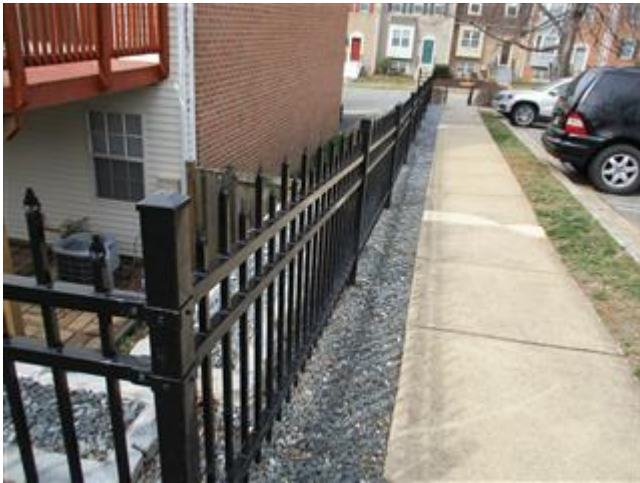
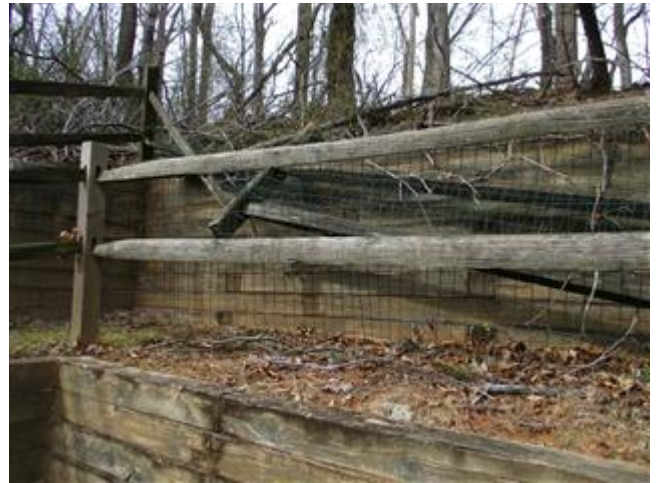
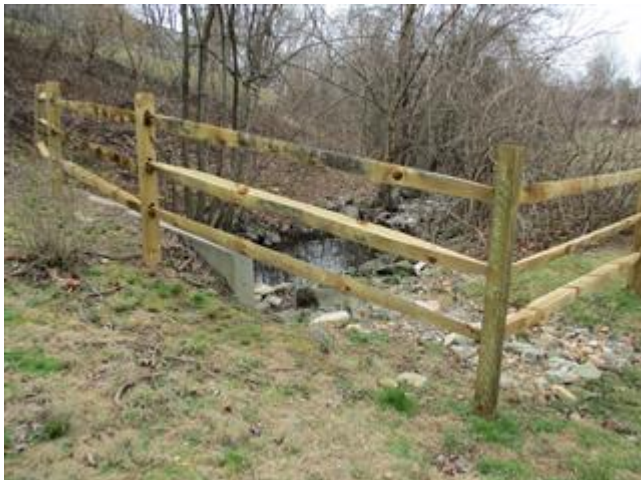
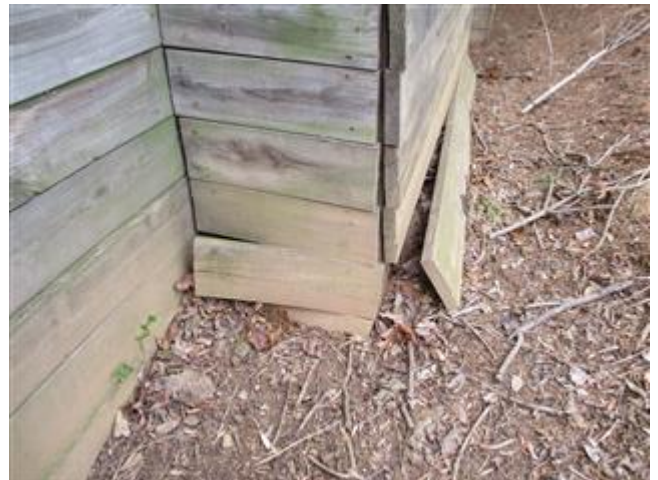
Fence Type	Linear Feet	Location/Description	Condition
Black, steel picket, 4'	630	Atop Redi-Rock wall numbers 3, 5, 7, 8, & 14.	Excellent
Split rail (3-rails)	1128	Currently atop Phase 2 walls 9, 10a&b, 12a&b, 18, & 19. It will be replaced with a 4' steel picket fence.	Fair-Poor
Metal, 35"	52	Currently atop the brick retaining wall (Wall #13) at 12 Lazy Hollow Dr. Likely will be replaced with 4' steel picket fence. In 2016, work was done to re-sleeve 11 railing posts.	Fair
Split rail, drainage area	32	Newly installed near east-end soccer field drainage pipe (see photo).	Excellent
Shadow box, PTL 6'	285	Perimeter fence along Great Seneca Hwy. Requires repair of individual boards.	Fair
Horizontal slat, PTL 6'	750	Perimeter fence along Great Seneca Hwy. Requires repair of individual boards.	Fair

Pressure-treated wood fencing should be cleaned and sealed every year or two. Typically, the least cost fencing option, this type of fence can last 15 to 20 years if maintained properly.

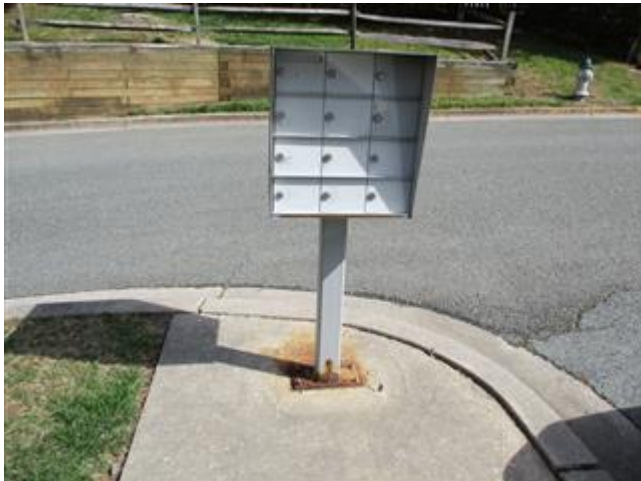
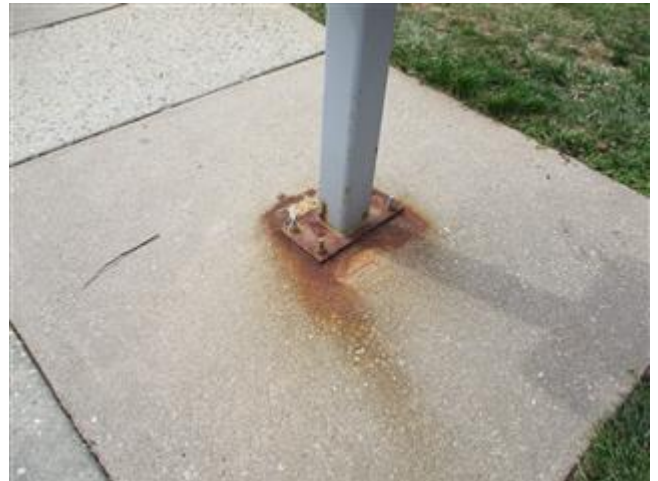
**Mailboxes.** Cluster mailboxes are located throughout the community and are in fair condition albeit with widespread pedestal rust and some rust on the box structures. In 2018, repairs were made to two mailbox structures on Leafcup Court to grind and remove rusted bolts and then to re-secure the bases (total cost \$950). Many more such repairs should be anticipated before these mailboxes are replaced.

Mailboxes should be maintained to the extent that rust does not develop on the structure or pedestal, and all mail slot doors remain intact with operable hinges and locks. Our replacement estimate assumes that these units will be replaced with fiberglass or composite units in the future.

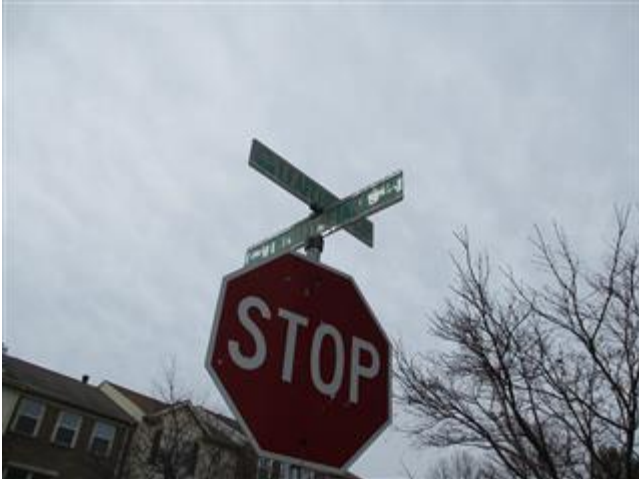
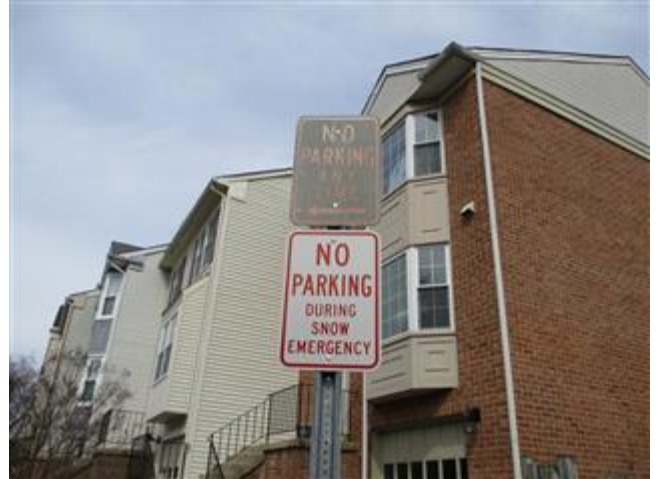
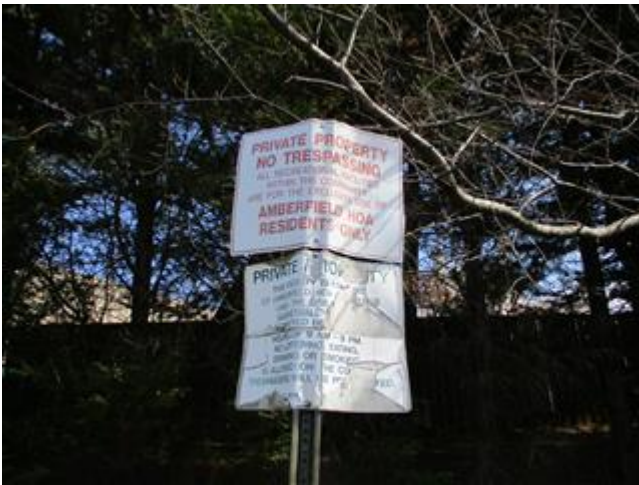
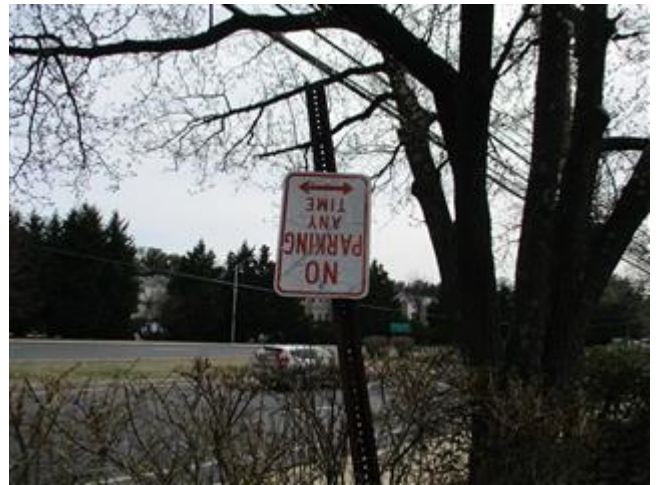
**Signage.** The Association is responsible for the street-name signs and other road/notice signs throughout the community. The community signs are in generally good condition; however, we did observe a few damaged street-name signs, a number of faded or damaged road/notice signs, and a few tilted signposts. These should be repaired in the near term.

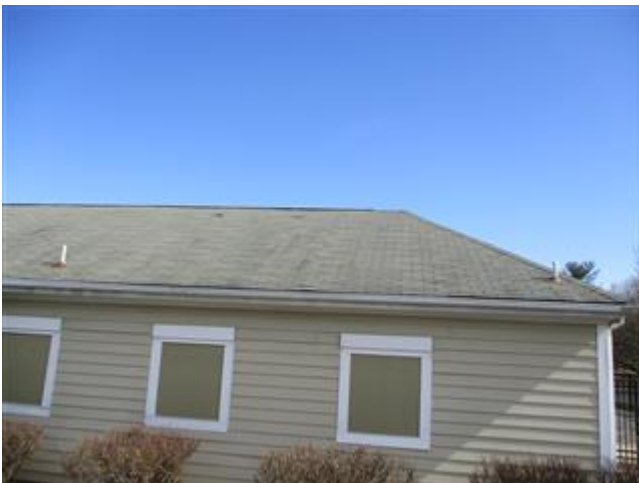
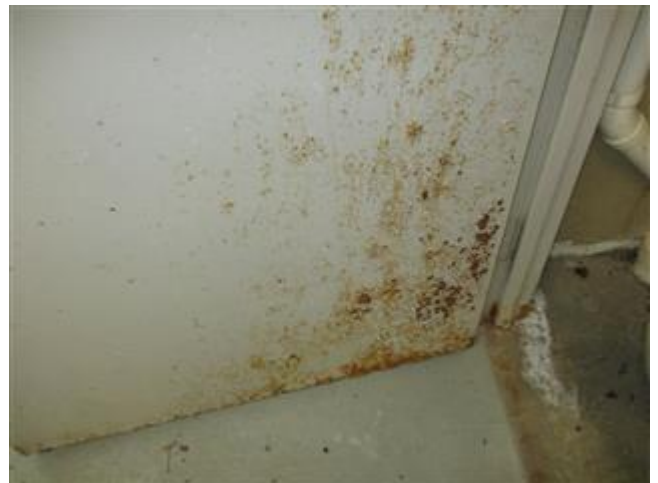
**Pool House Interior/Exterior.** The Association is responsible for the maintenance of the entire pool area, including the pool house interior and exterior. The pool house is a simple, low-maintenance structure with painted cinder block interior walls, concrete floors, synthetic board exterior siding with PVC trim, and an asphalt shingle hip-style roof. Paint on the interior and exterior wall surfaces appears to be in good condition. The concrete floors in the men's and women's rooms are coated, and management has indicated that these floors will be re-coated in the near term.

The roof shingles are in marginal to poor condition with an overall weathered appearance and some curled shingles visible from the ground. Annual inspections are recommended, with cleaning, repair, and mitigation of vegetation performed as needed. Access, inspection, and repair work should be performed by contractors and personnel with the appropriate access equipment who are experienced in the types of roofing used for the facility. Asphalt shingle roofs can have a useful life of 20 to 50 years depending on the weight and quality of the shingle. Weathered, curled, and missing shingles are all indications that the shingles may be nearing the end of their useful life. Gutters appear to be in fair to good condition.

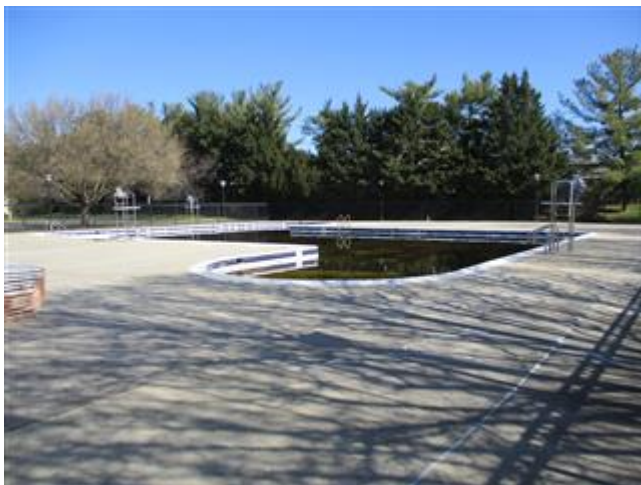
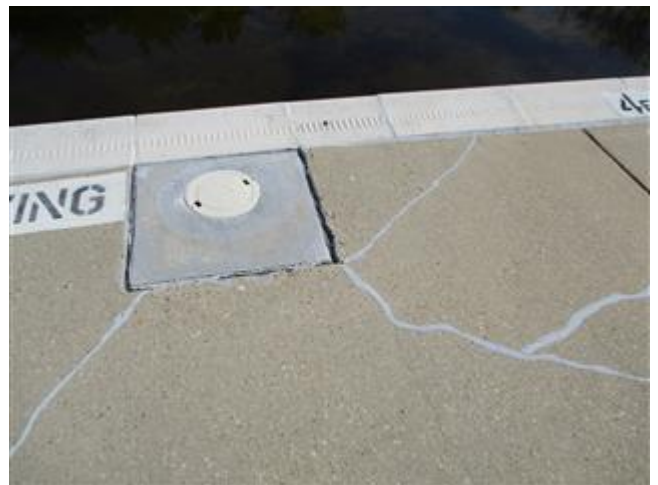
**1. Pool Deck.** The pool deck consists of approximately 12,400 square feet of cast-in-place concrete. The deck appears to be in fair condition with many repaired cracks and a wavy depression on the east side of the main pool. In 2016, deck work was done to remove and replace several damaged concrete pads and to saw cut and caulk deck cracks. Also, deck expansion caulk was removed and replaced. Management has indicated that the pool deck will be renovated within the next 10 years.

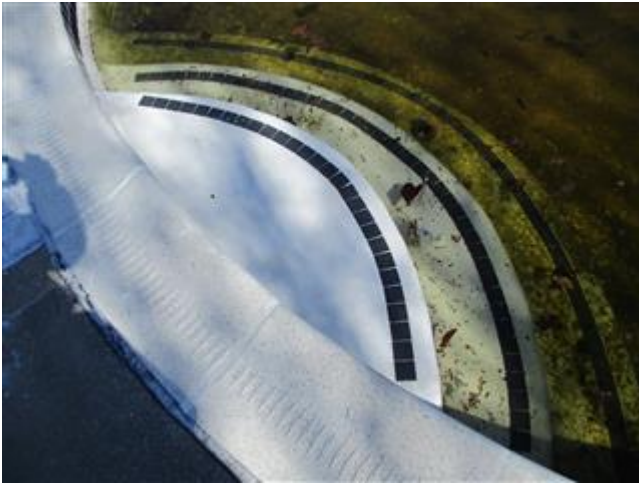
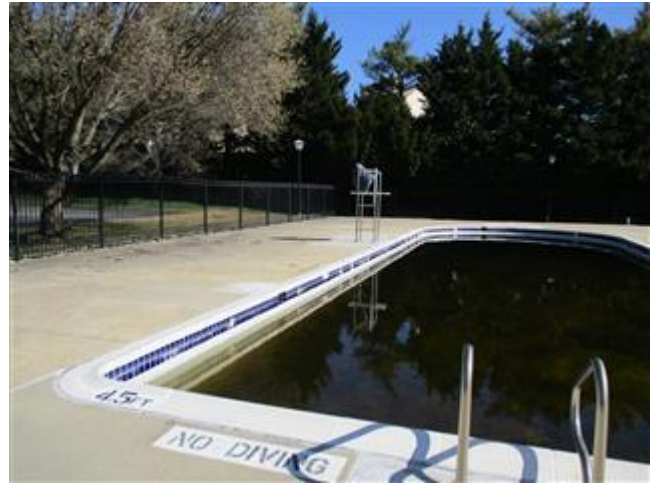
- The pool white coat was difficult to observe due to dark water and debris in the pool; however, management did indicate that a new white coat would be applied after the upcoming pool season.

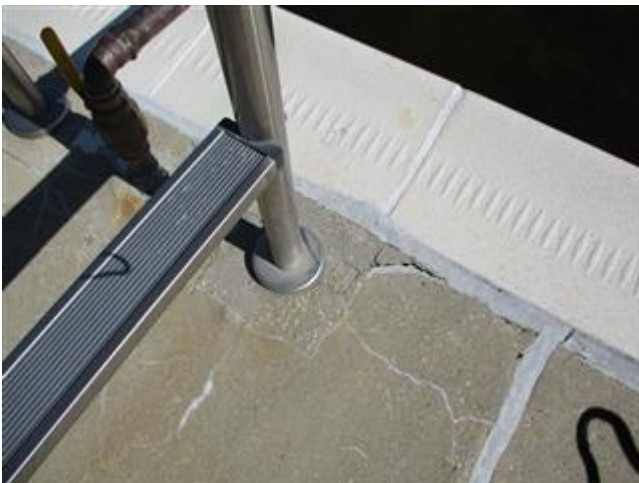
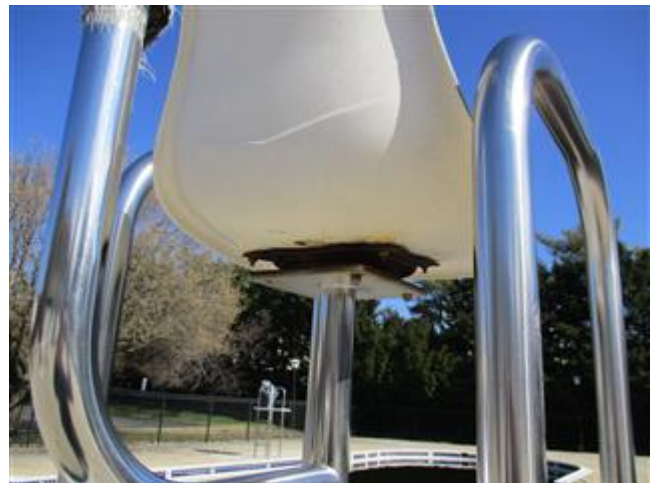
**3. Lifeguard Stands and Grab Rails.** There are three lifeguard stands and three sets of grab rails attached to the pool deck around the main pool. During our visit, two of the lifeguard seats were covered. The uncovered seat was stable, but the metal plate and bolts connecting the seat to the stand were rusted and the plastic seat exhibited small cracks around the connection. Assuming that the other two seats are in the same condition, these seats should be repaired or replaced in the near term. The metal stands and their connections to the pool appear in good condition. In 2016, all the old grab rails were removed, and new ones were installed; they remain in excellent condition.

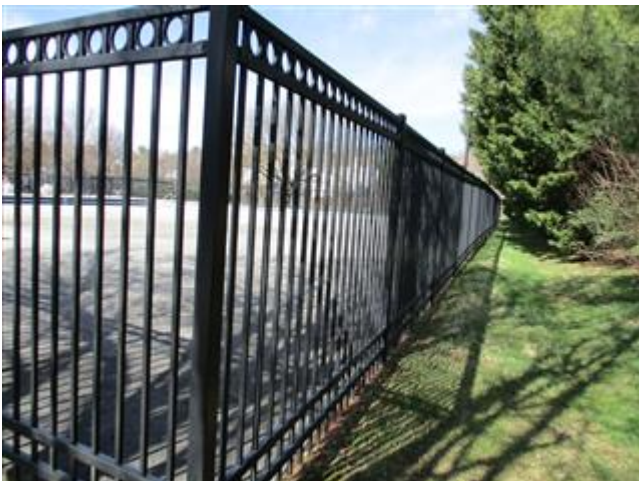
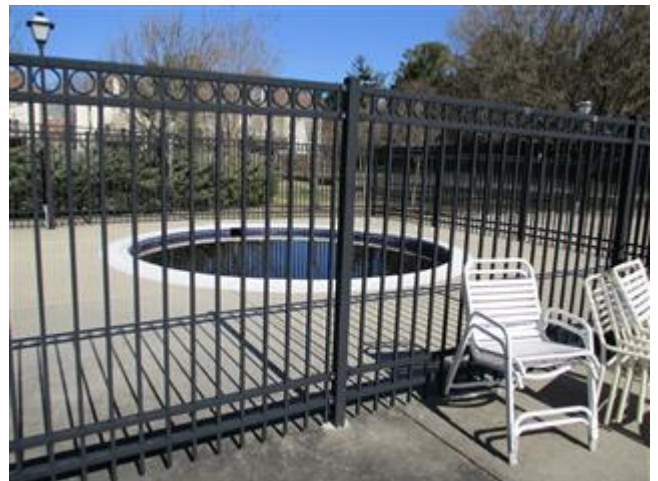
**4. Pool Fencing.** The total pool deck and the wading pool area are bordered by roughly 540 linear feet of six-foot-high, decorative steel fencing. Currently, all of the pool area fencing appears to be in good condition.

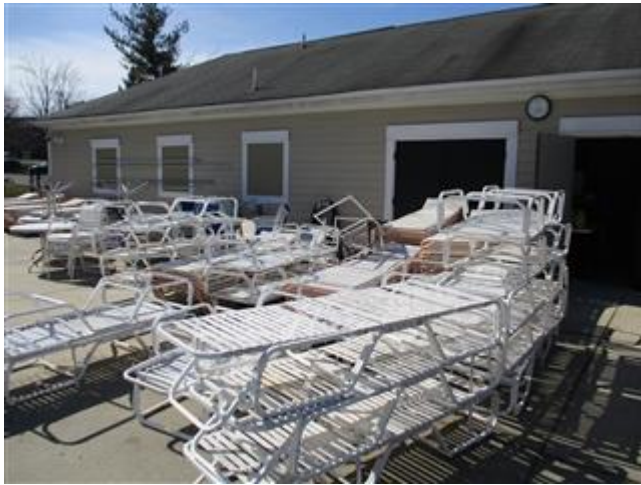
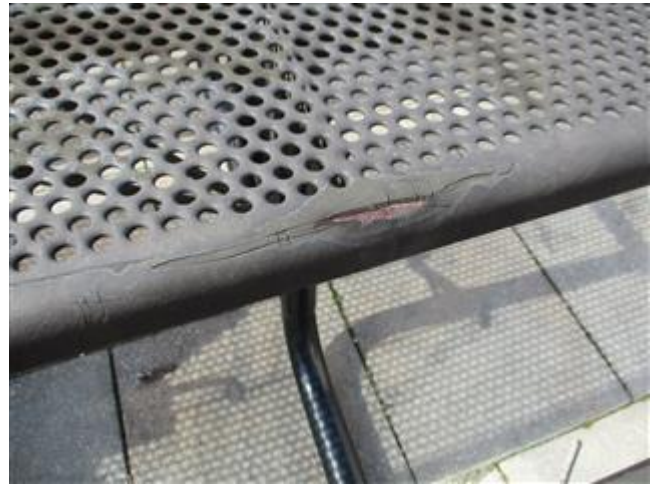
In general, the pool furniture appears to be in fair to good condition. To prolong the service life of the pool furnishings, we recommend that, during the cold-weather season, the furniture be stored under shelter as much as possible or under breathable (to prevent mildew) tarps.

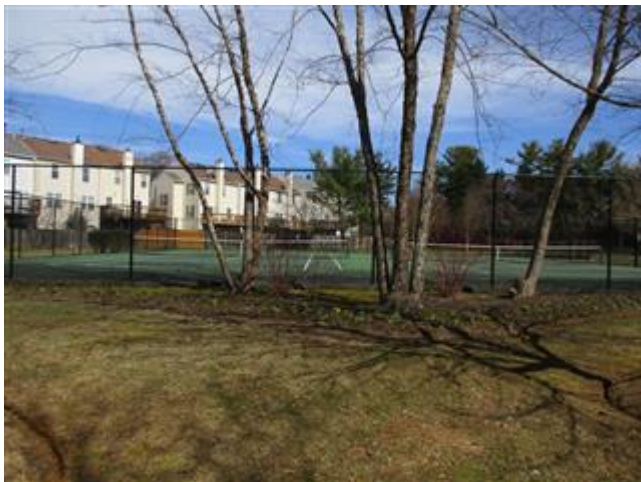
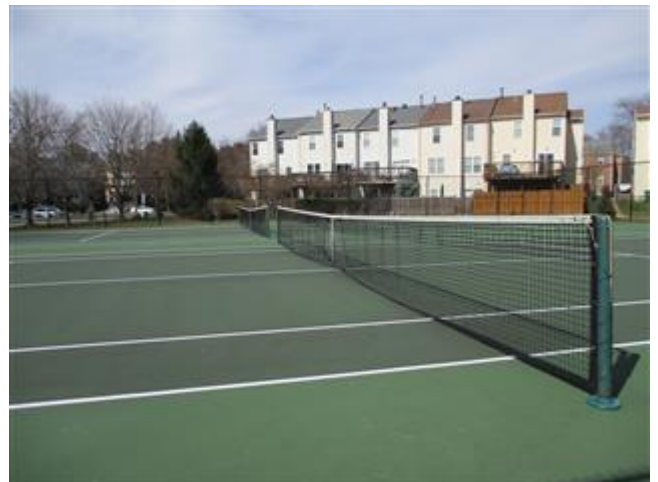
**Tennis Courts and Multi-Purpose Court.** The community maintains two tennis courts, surrounded by one fence, located just north of the pool area on Suffield Drive. The tennis court surfaces appear to be in good condition; a cleaning before the spring season is recommended. The fencing and the nets are in good condition.

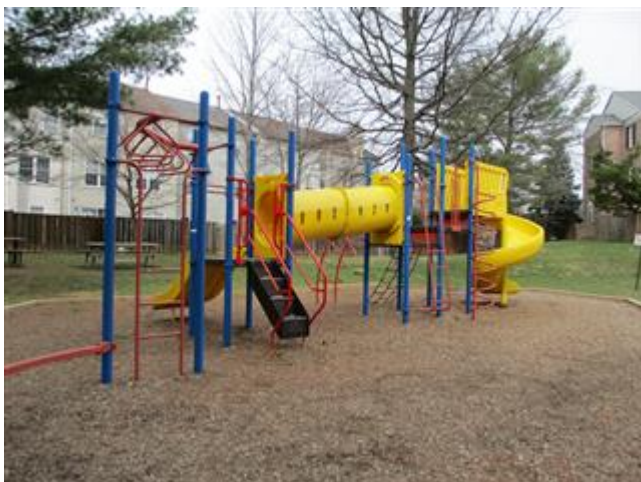
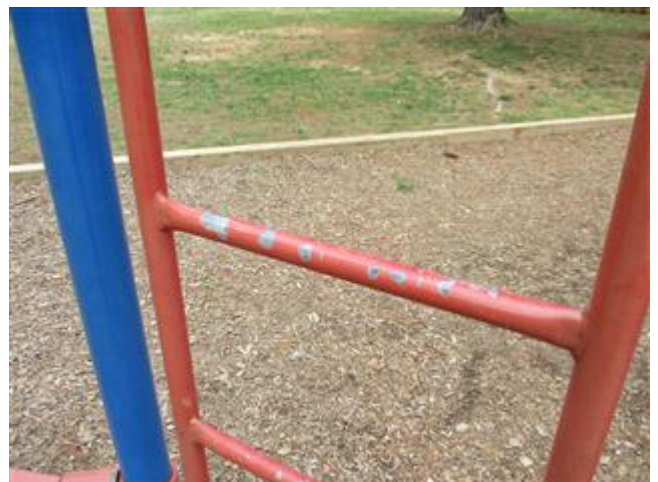
**1. Lazy Hollow Way Tot Lot.** The Lazy Hollow tot lot is located behind the townhomes on the south side of Lazy Hollow Way. The tot lot features one large play structure. This structure is in generally good condition; however, we did observe wear on one set of ladder steps and the attached chain ladder. These two items should be repaired or replaced in the near term to help extend the total life of the structure. In 2019, one set of 36" stairs was replaced on the play structure. The tot lot border (6" x 6" timbers, replaced in 2018) and the surface (replenished in with 20 cubic yards of wood chips in 2018) is in excellent condition. Two picnic tables are on site. The wood and metal table is in poor condition, while the plastic and metal table is in good condition.

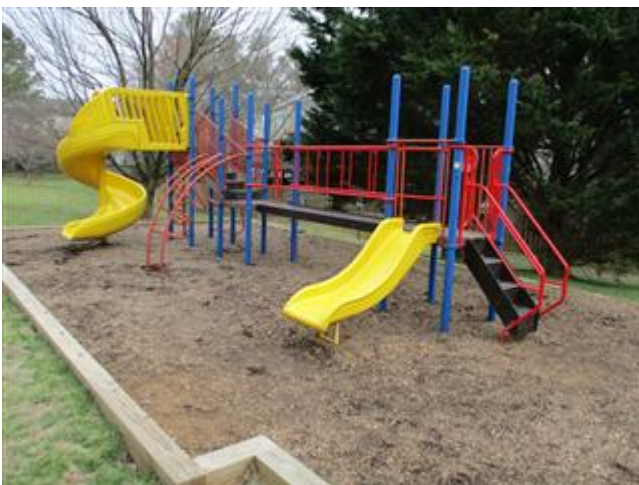
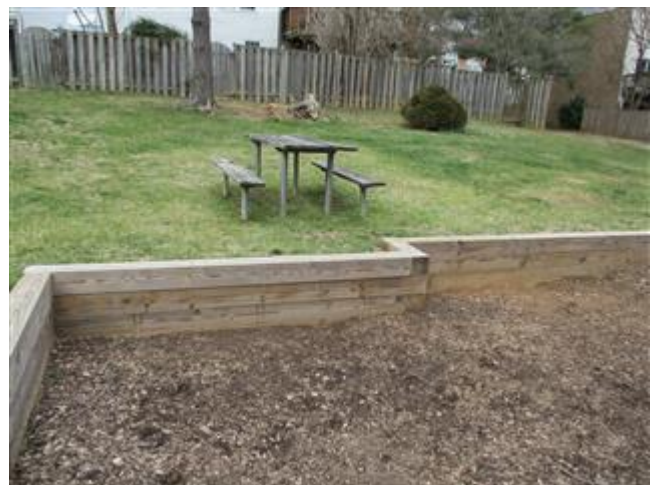
There are also three wood and metal picnic tables on-site. They are in poor condition.

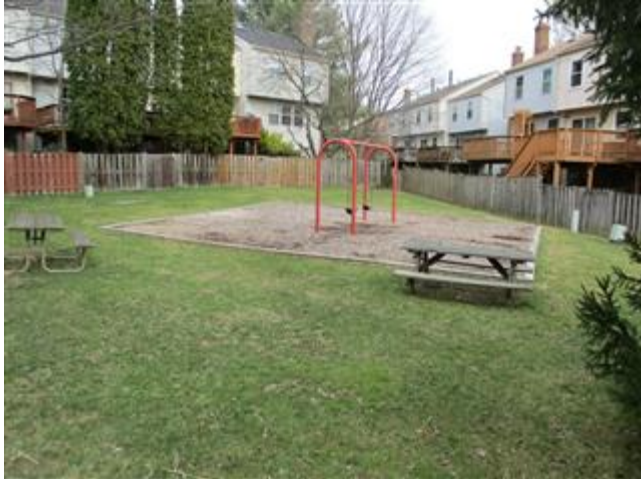
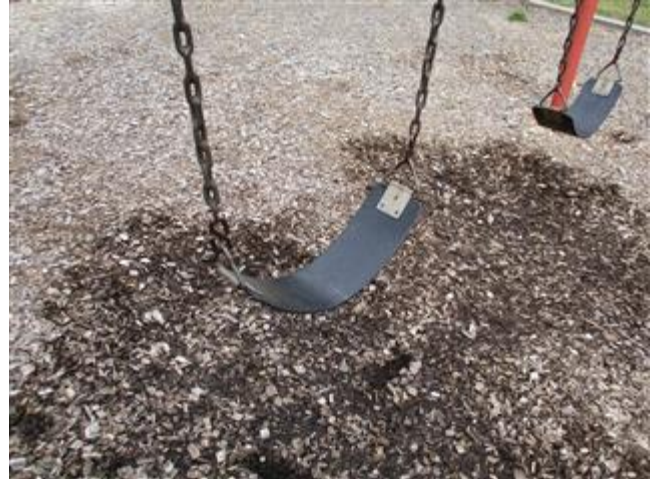
There are two wood and metal picnic tables on-site; they are in marginal to poor condition.

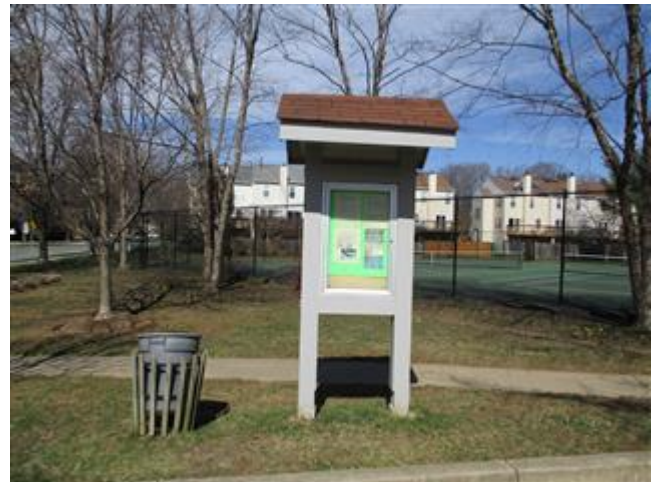
**Community Message Board.** The community's glass-door message board is housed in a small kiosk constructed of painted pressure treated lumber and a small, A-frame shingle roof. The message board and its enclosure are in good condition.

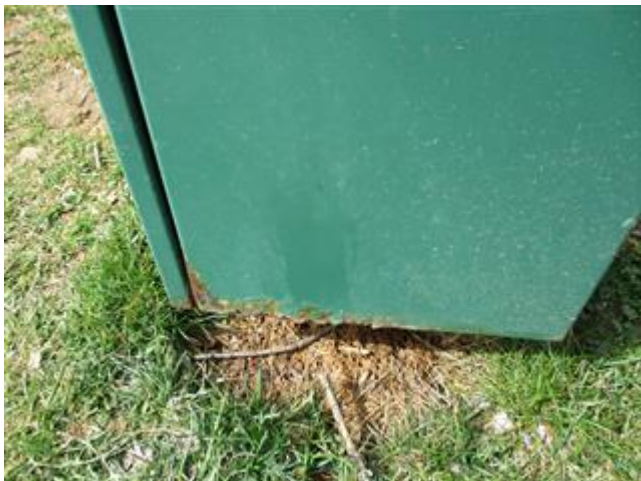
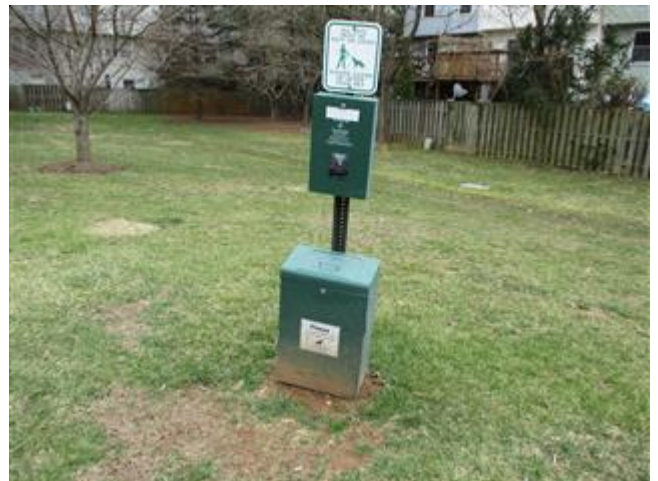
**Dog Waste Stations.** Seven dog waste stations are conveniently located throughout the community. They appear to be in generally good condition. We did notice rust at the bottom of one station near Earth Star Court. Also, the station near the Fleece Flower tot lot should be raised on its post to help prevent rust from ground moisture.

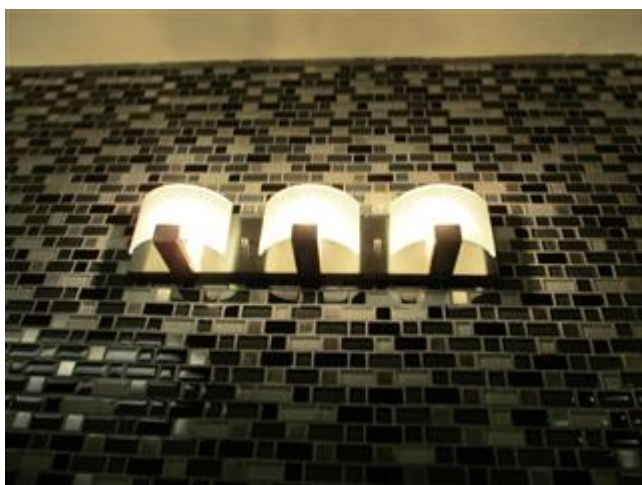
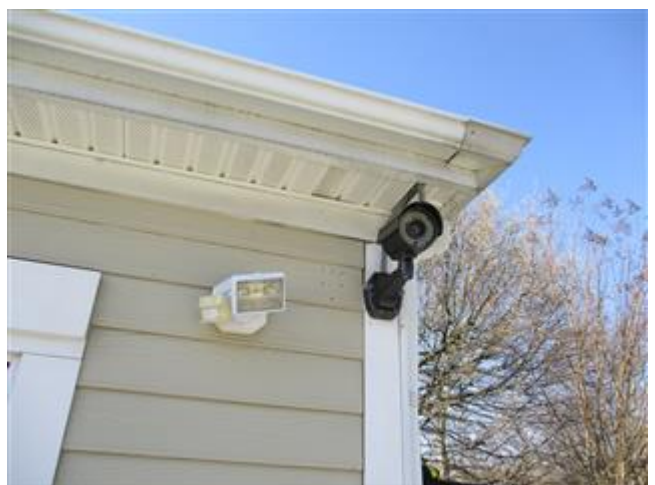
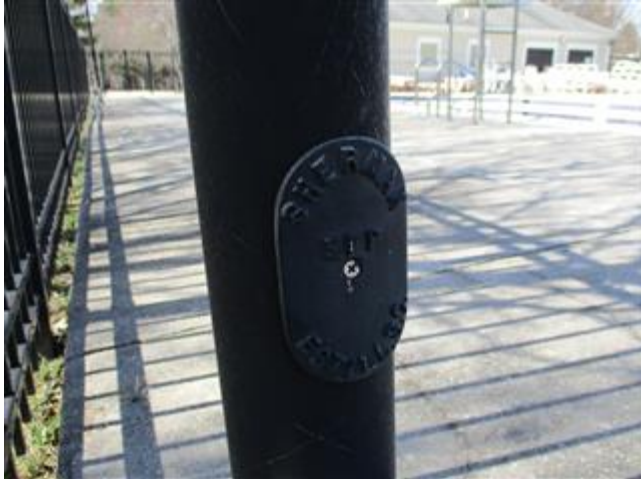
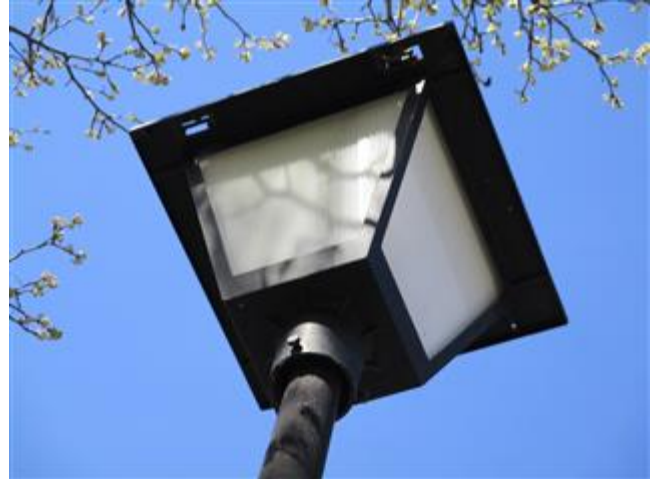
Pool house interior and exterior lights appear to be in good condition. There are eight-pole lights mounted into the pool deck just inside the perimeter fencing. The light poles are ten-foot, single-lamp fiberglass poles, and the lamps are LED. They also appear to be in good condition.

This study assumes replacement of the light fixtures every 15 to 20 years, and pole replacement every 30 to 40 years. When the light poles are replaced, we assume that the underground wiring will also be replaced.
