# LEVEL 1 REPLACEMENT RESERVE REPORT FY 2020 AMBERFIELD HOA

## AMBERFIELD HOA

GAITHERSBURG, MARYLAND

March 5, 2020

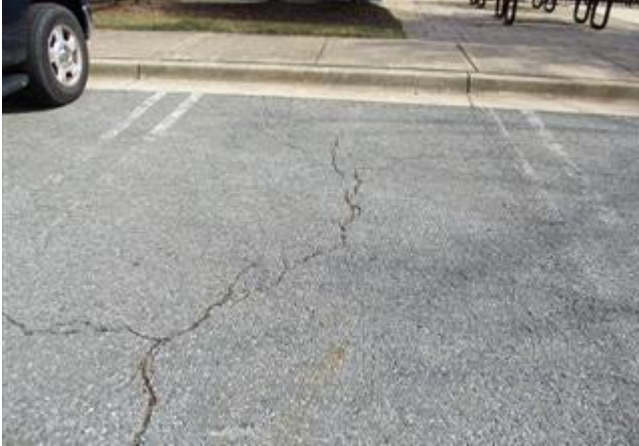
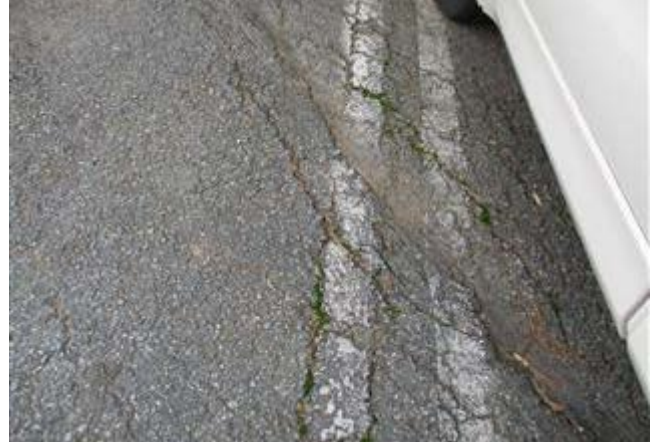
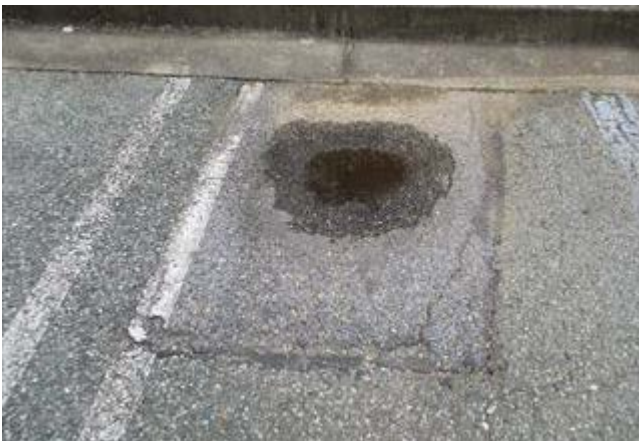
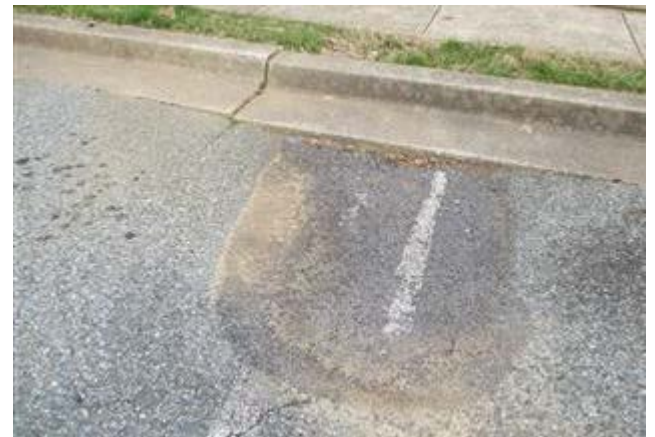
In general, the Association’s asphalt parking spaces are in marginal to poor condition. We observed a large number of cracks and a lesser number of depressions. Some parking areas were worse than others, for example, the asphalt was particularly poor on Autumn Flower Lane and Narrow Leaf Court. Parking space paint conditions also varied throughout the community. For example, the paint on Lazy Hollow Way was in good condition, while the paint on Twisted Stalk Drive was barely visible.

The defects noted include the following:

- **Open Cracks.** There are multiple locations where open cracks are allowing water to penetrate to the asphalt base and bearing soils beneath. Over time, water will erode the base and accelerate the deterioration of the asphalt pavement. If cracks extend to the base and bearing materials, remove the damaged areas and replace defective materials. As a part of normal maintenance, clean and fill all other cracks.

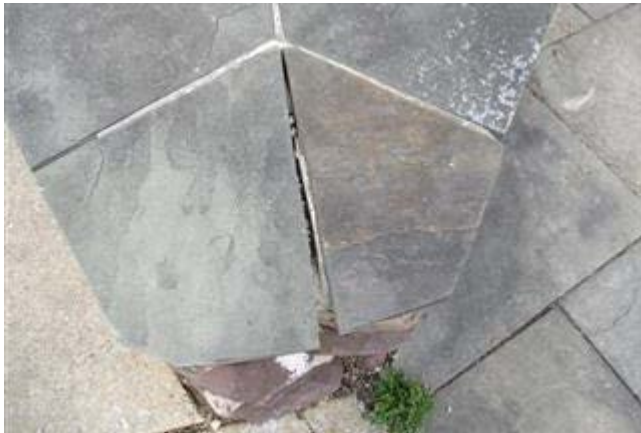
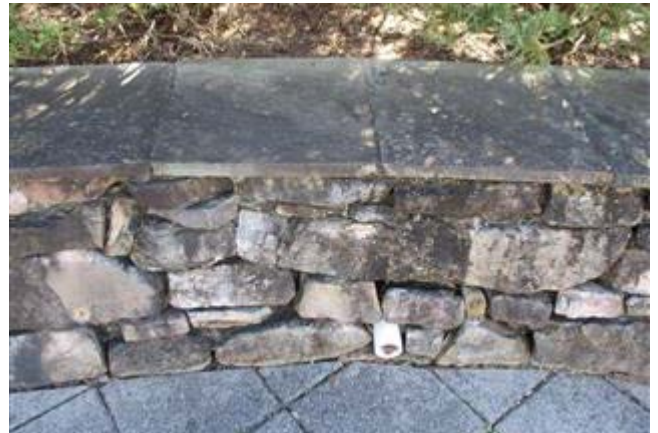
**Small Masonry Walls.** The Association maintains at least seven small, loosely mortared masonry walls, totaling approximately 420 square feet of stone face-area. Five of these walls are located in the pool house area, one is at the intersection of Suffield Drive and Blazing Star Way, and the other is located at the intersection of Suffield Drive and Autumn Flower Lane. These walls are in generally good condition; however, we did observe a number of instances where mortar is cracking or displaced. Thus, we have included in the study an allowance for masonry wall repointing and repair.

Stone masonry walls can have an extended useful life of 40 years or more, and if stable, may only require periodic repointing and localized repair. Repoint is the process of raking out defective masonry joints and tooling in new mortar into the joints. Properly mortared and tooled joints will repel the weather and keep water from penetrating the wall. Siloxane or other breathable sealants should be considered to provide additional protection to the wall from water penetration. This study assumes that repointing will be performed incrementally as needed.

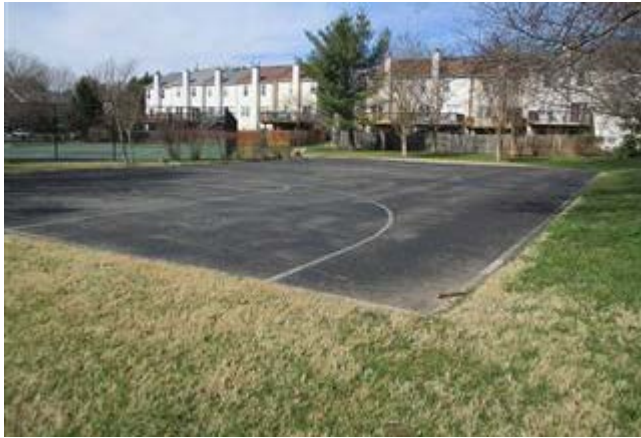
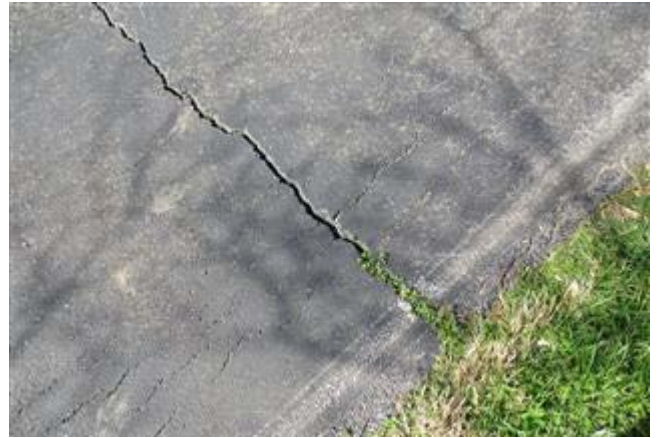
The community also maintains one multi-purpose, asphalt court, located just east of the tennis courts. The court is still marked as a basketball court, but the standards have been removed. The asphalt surface is in poor condition, with multiple cracks and at least one displaced chunk of asphalt. Management does not plan to remove the court, but they have stated that they will maintain the asphalt surface.

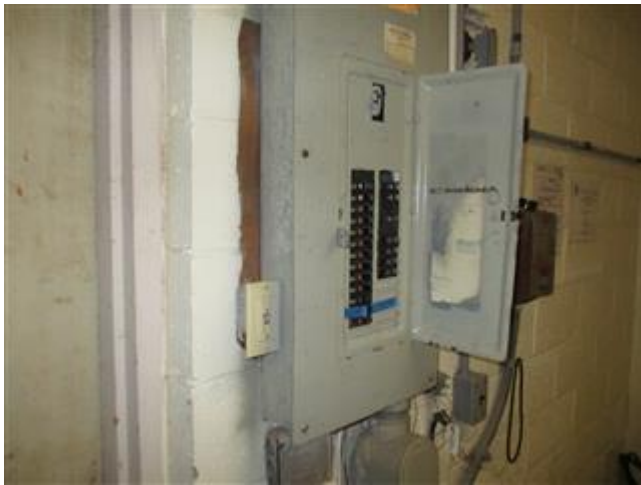
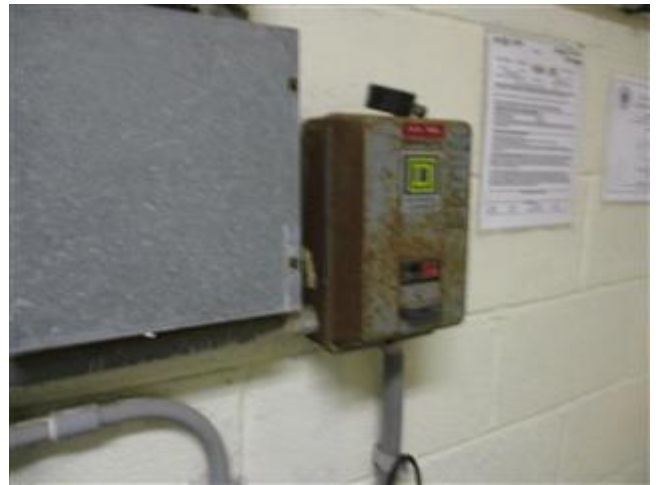
The overall condition of the switchgear appears to be good, but the humid conditions in the pool house contribute to rust and corrosion. In 2017, all existing circuit breakers were removed, and new breakers were installed (one double-pole 40 amp., 11 single-pole 20 amp., and three single-pole 40 amp.). Also, rust was sanded off the existing panel, and the panel was sprayed with cold galvanized spray to help prevent additional rust.

As the switchgear continues to age, obtaining replacement parts can be expected to become more difficult. When parts no longer are available or when the condition of the switchgear deteriorates sufficiently, the Association will have to replace or upgrade the existing equipment. Therefore, we have included funding in the reserve analysis for distribution panel replacement on an incremental basis.

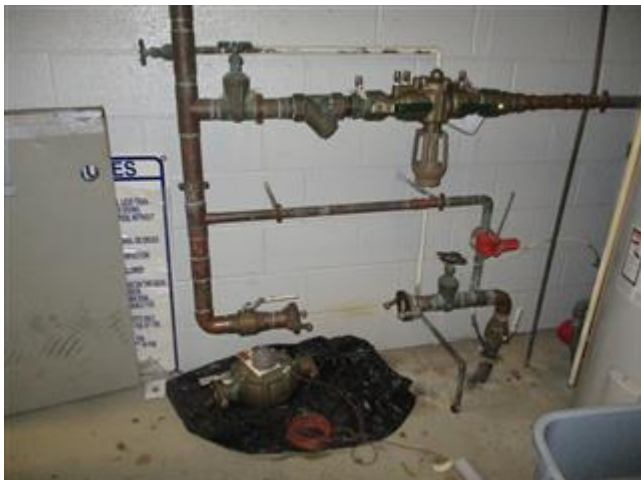
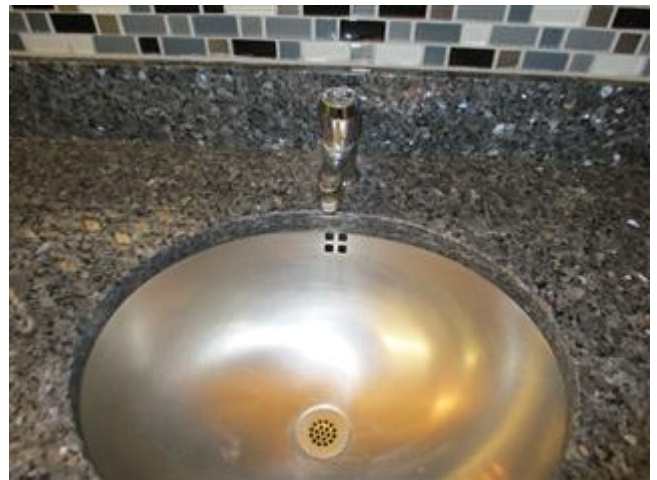
**2. Pool House Plumbing.** At the time of our site visit, all plumbing had been decommissioned for the cold season, so we could not confirm the service condition. We do know that the following work was performed, by a certified plumbing company, within the last five years to address defects and aging in the plumbing systems.

- In 2016, the following pool house plumbing fixtures were replaced: hot water mixing valve, anti-scold devices on all nine showers, three showerheads in the men's room.
- In 2017, a new water heater was installed in the pool house: Bradford White Hydrojet ElectriFLEX 119 gallon Commercial Light Duty Upright Electric, model number LE2120T33.
- In 2019, the following fixtures were replaced: self-closing shower valve, and cartridges to fix two push faucets.

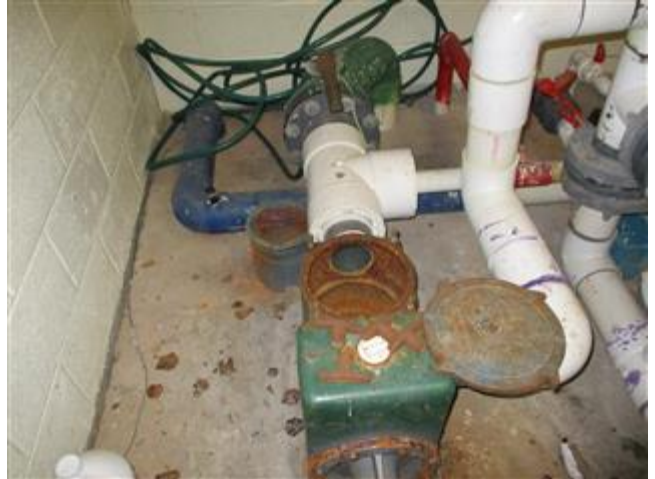
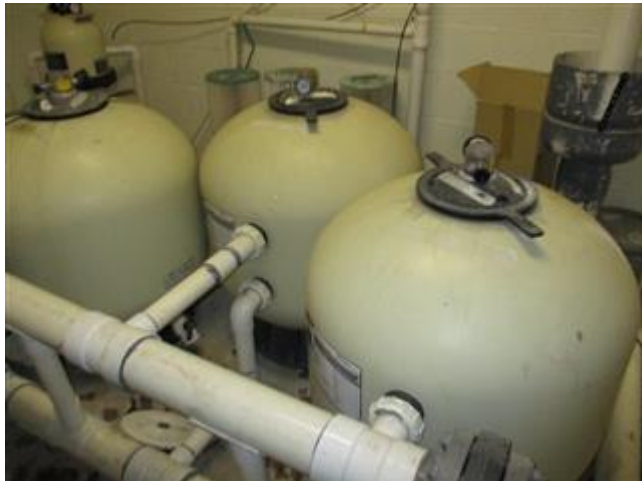
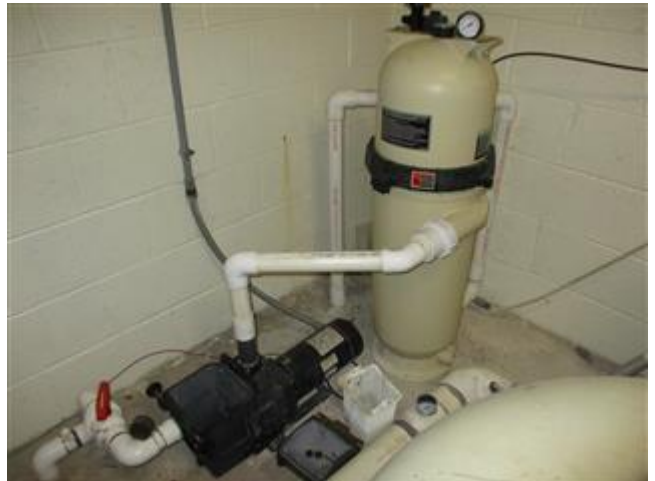
**3. Pool Pumps and Filters.** Again, all pool plumbing had been decommissioned at the time of our site visit, but the Association has been servicing components as needed, and they did not report any nonfunctioning components. That being said, according to the 2016 reserve study, the wading pool pump is due for replacement in 2020, so we recommend that the wading pool pump be evaluated and serviced or replaced, as necessary. The following work was performed, by a qualified pool professional, within the last five years:

- In 2016, the sand was recharged in the main pool filters (Pentair Triton II side-mount filter TR100 fiberglass sand filters).
- In 2016, a new wading pool filter was installed. The filter appears to be a Pentair 160353 Clean & Clear RP fiberglass-reinforced polypropylene tank cartridge pool filter, 200 Square feet, 150 GPM.

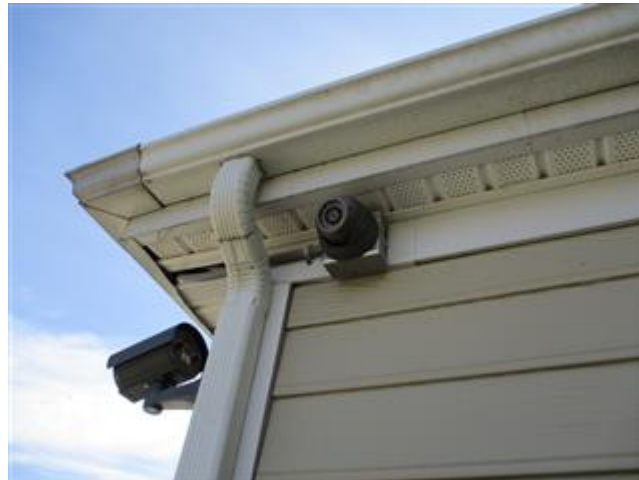
**Security Camera System.** The pool area is surveilled by four security cameras (two large and two small) mounted on the pool house. The cameras are controlled via monitoring equipment housed in a locked room inside the pool house. The security system was installed in 2013, and the cameras appear to be in good condition.
